Title: A Chronicle of Research for the Fort Ross Visitor Center

Author(s): David_Rickman

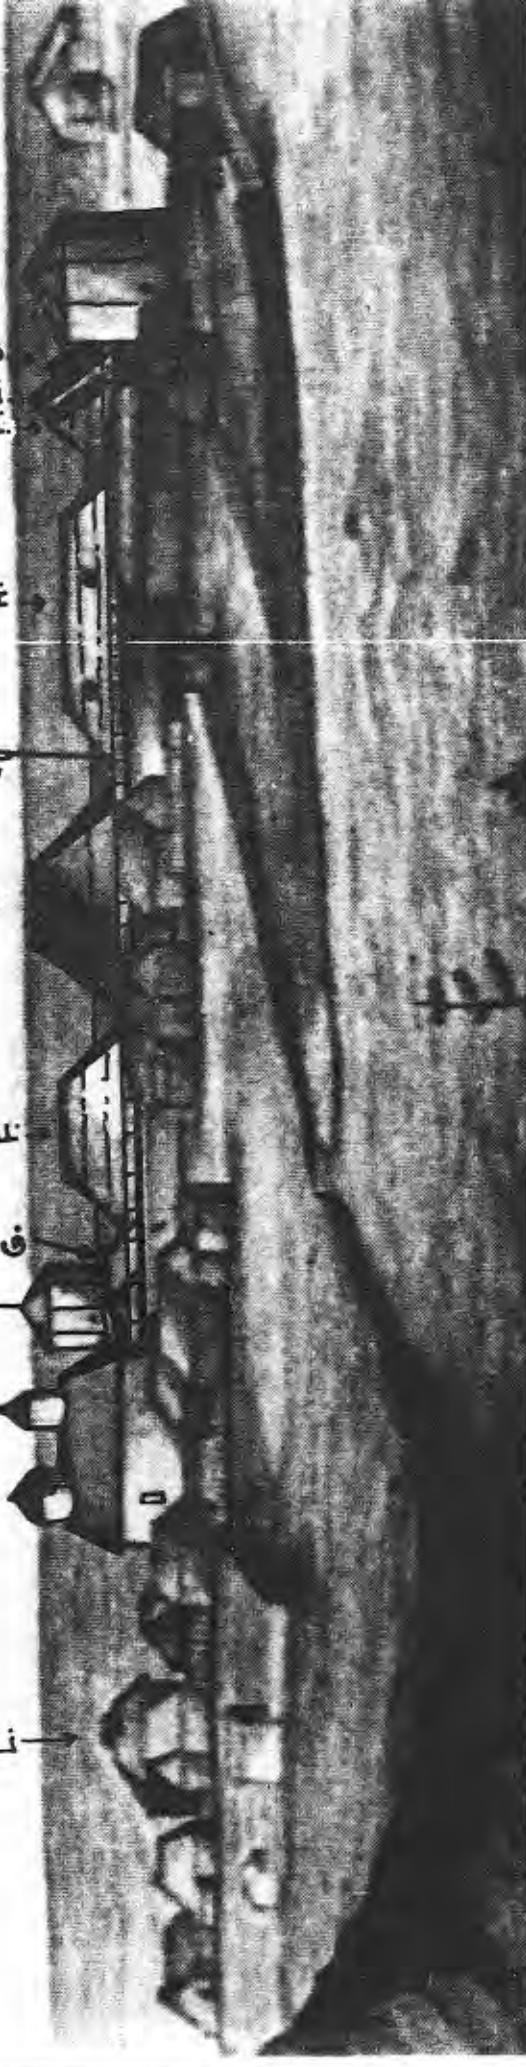
- A. South (8-Sided) Bastion
- B. North (7-Sided) Bastion
- C. Chapel
- D. Kuskov House

- E. Old Warehouse
- F. Provisions Warehouse
- G. Employees' Barracks
- H. Officials' Quarters

- I. Unidentified Post next to Main Gate.
- J. Ratheo House
- K. Windmill

- L. Outbuilding with gabled Ventilator.
- ? Unidentified building NW of Old Warehouse. New Kitchen?

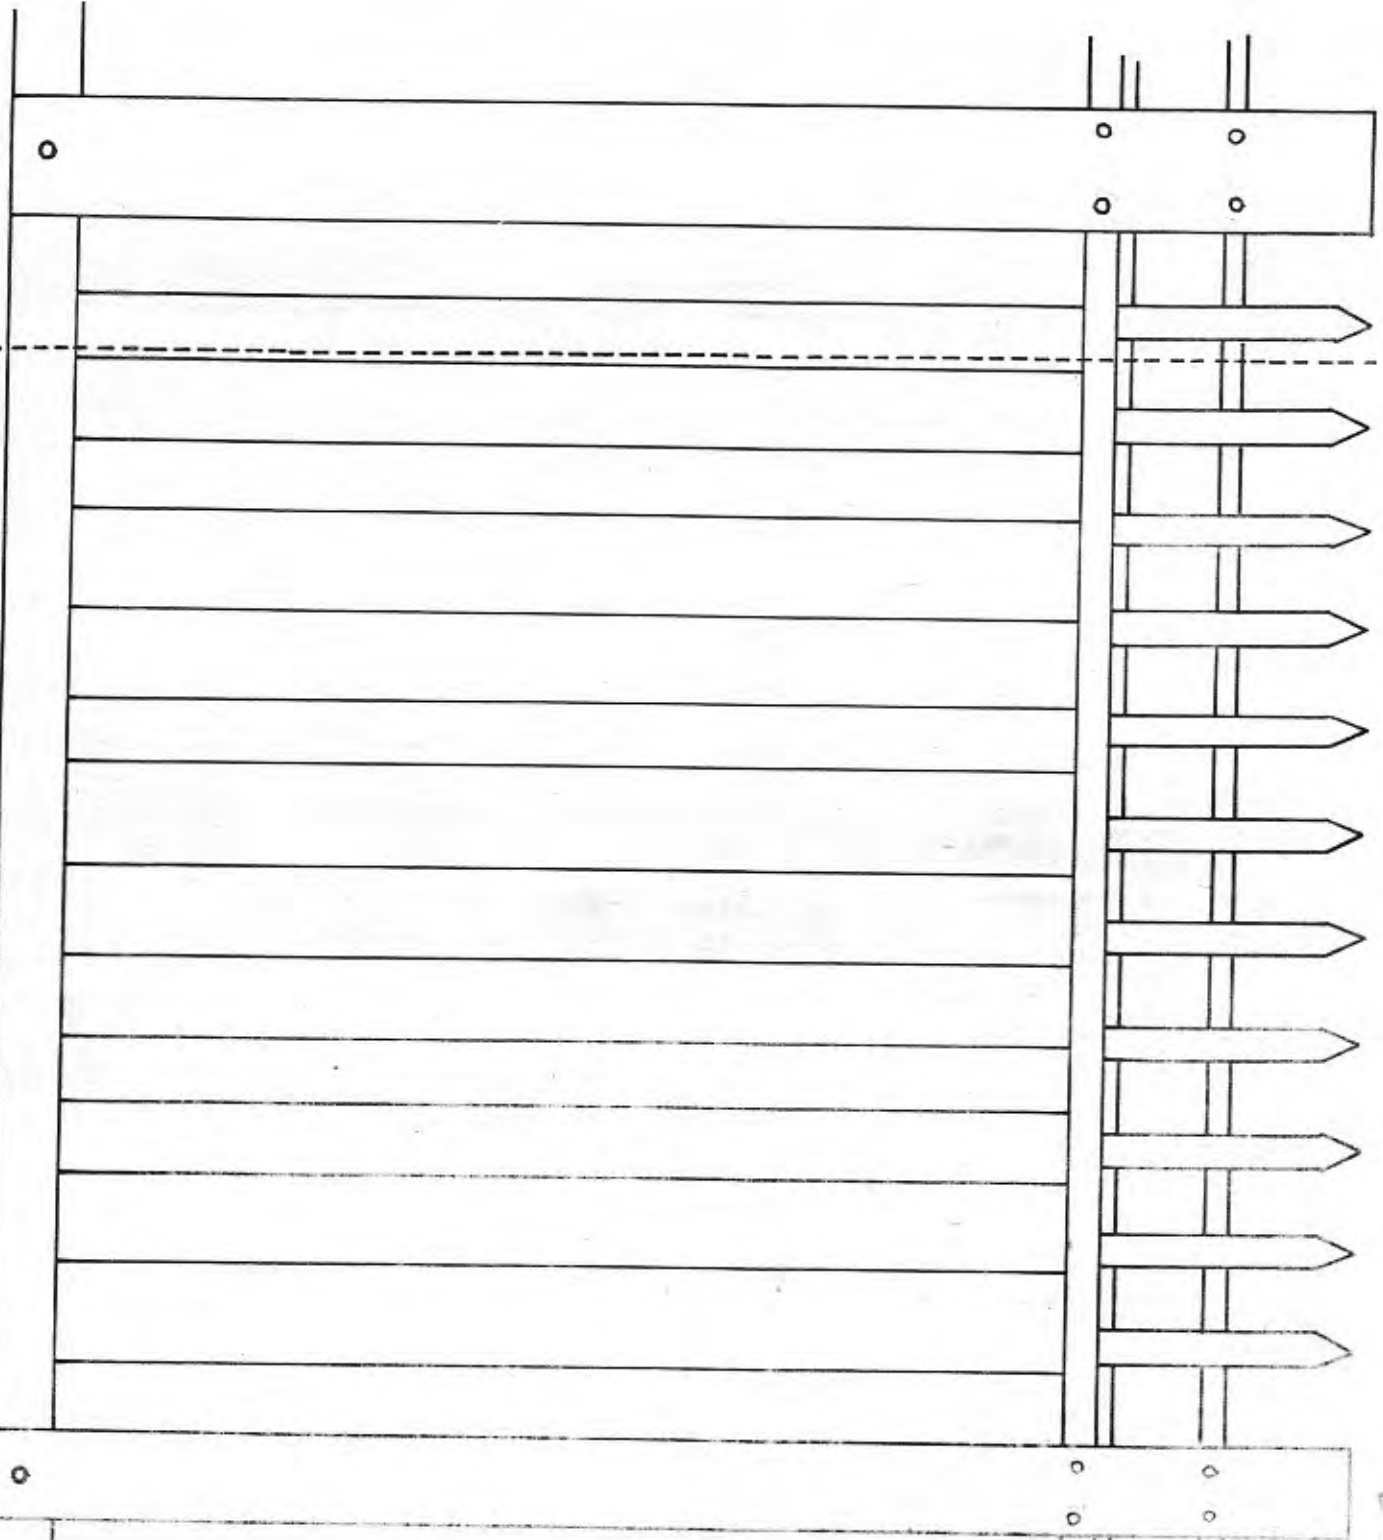
ELEVATION and SECTION of WALL, FT. ROSS
SCALE: 1/2" = 1'0" Drawn by DAVID RICKMAN 1-16-24

SECTION THROUGH
POINTS a./b.

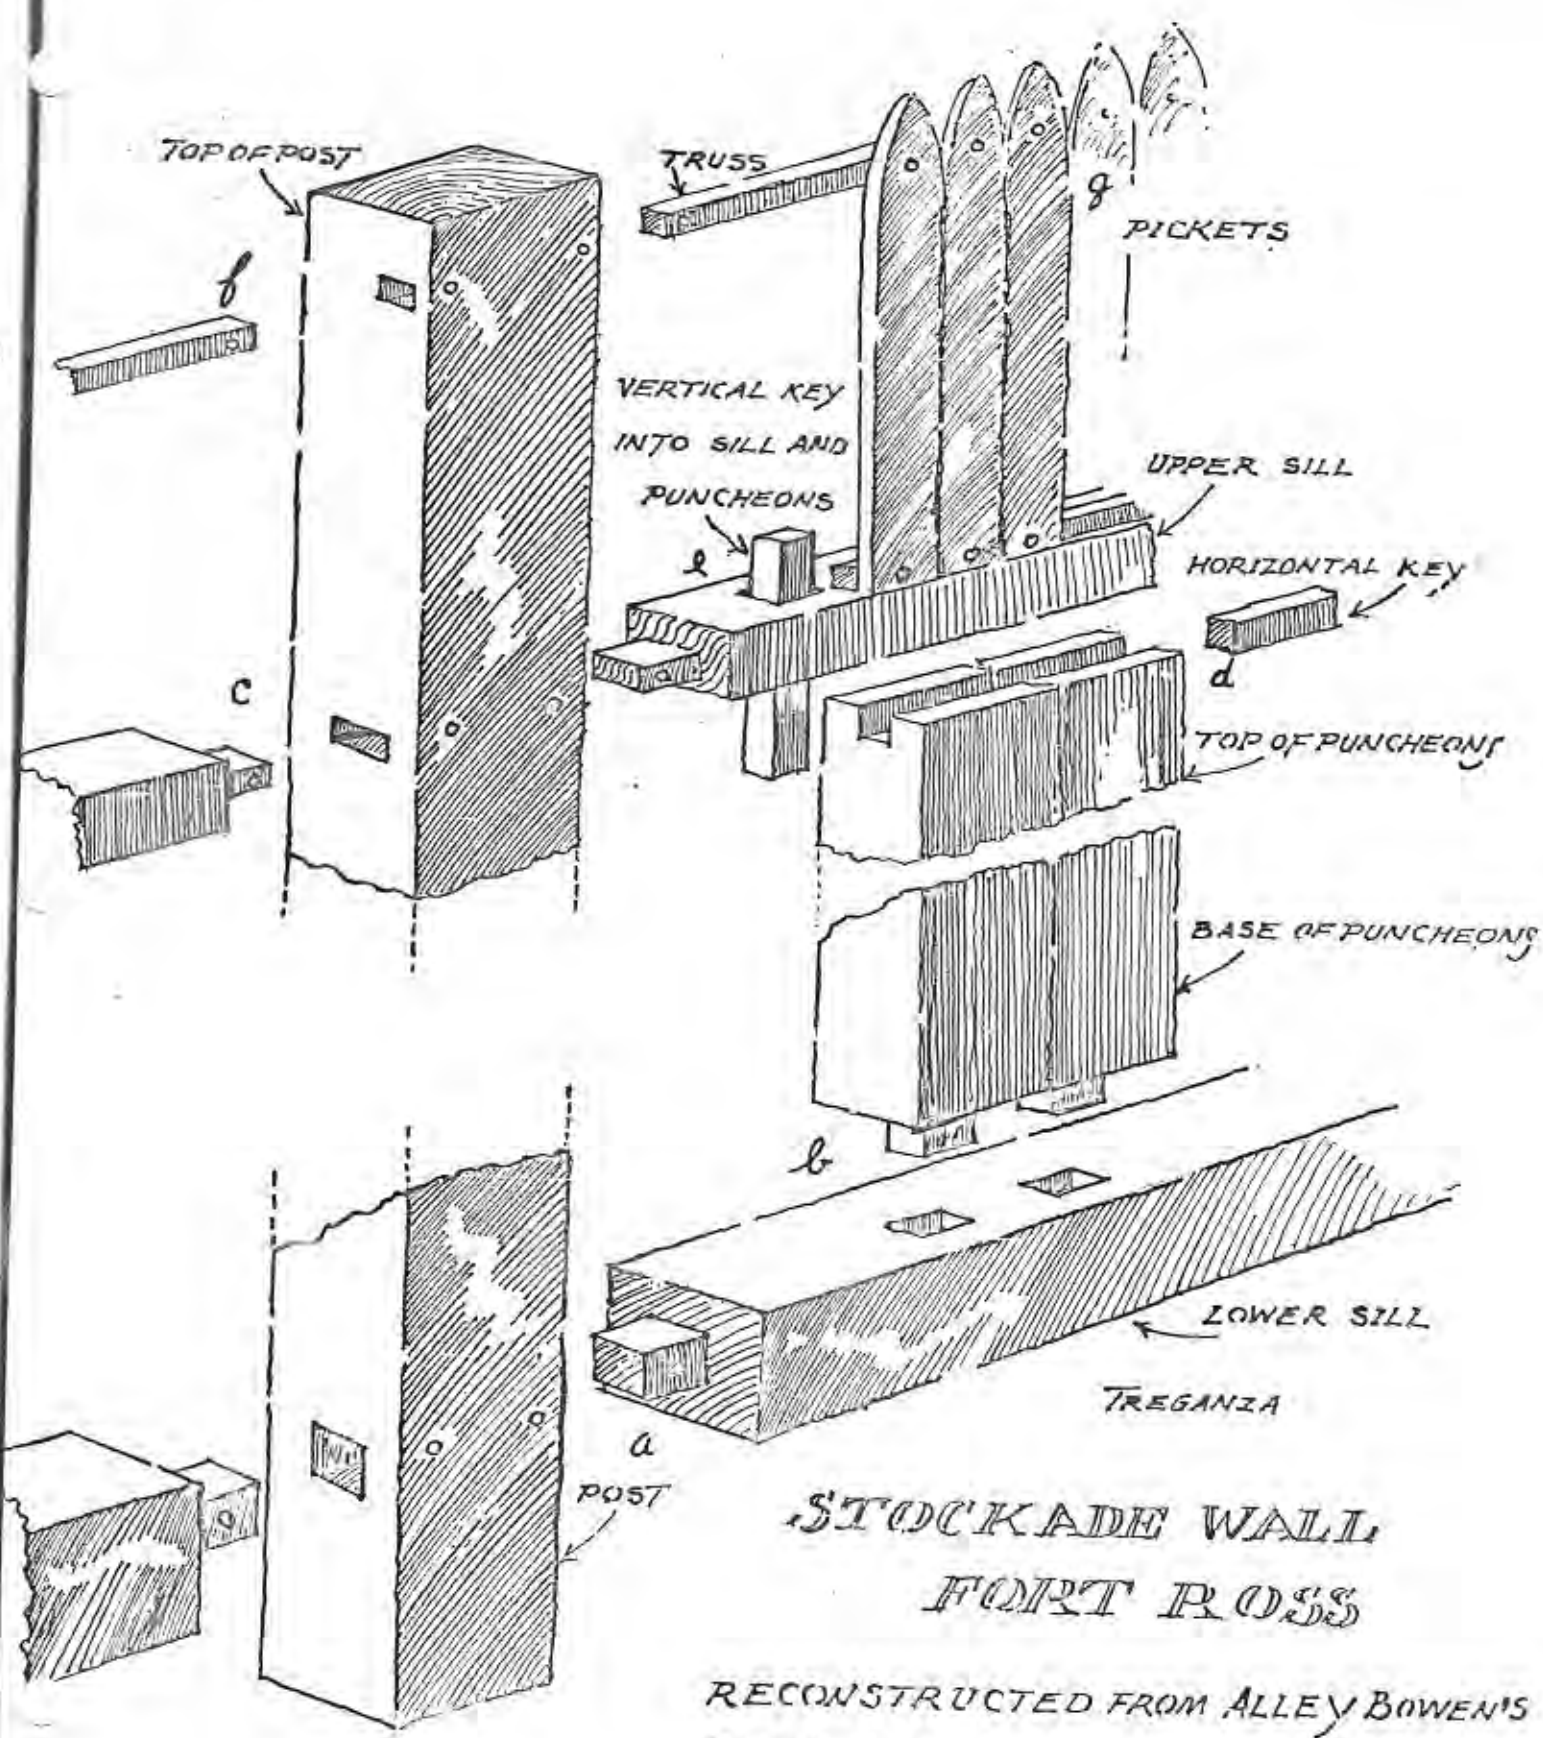
STOCKADE WALL
FORT ROSS

RECONSTRUCTED FROM ALLEY BOWEN'S
VERBAL DESCRIPTION IN 1880

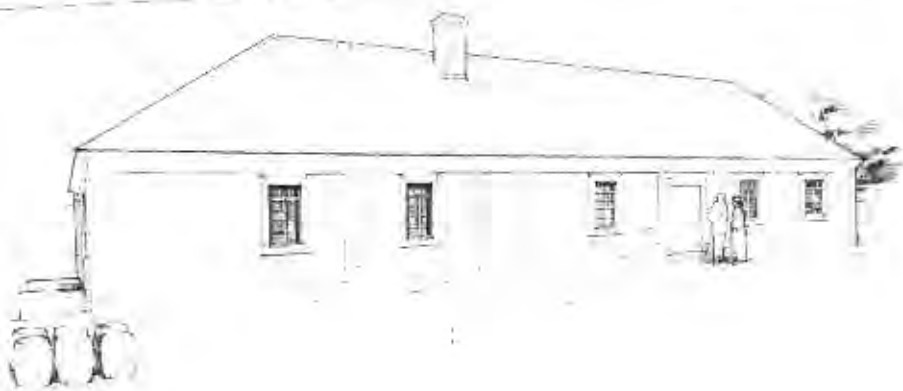
Fig. 44.

The many visitors to Fort Ross — traders, officials, sailors, and travelers — were probably given temporary quarters in the Official's Barracks. Perhaps they would stay a few days, conducting business and exchanging news, and then depart for the next port of call.

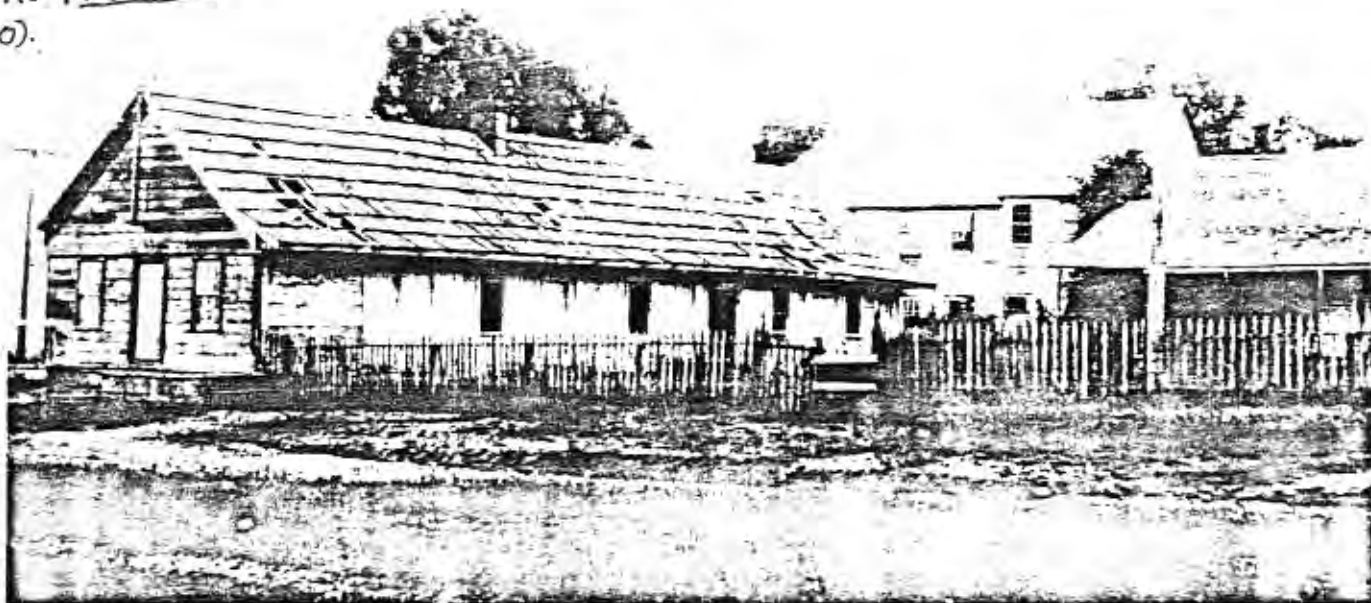
Fig. 46

Official's Quarters, Ross
prob. prior to 1906

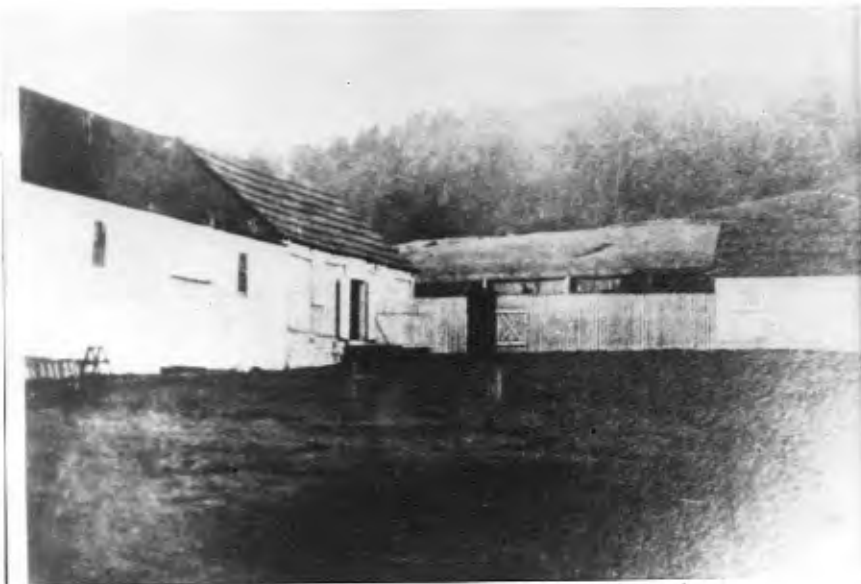
Figure 7. Photo of the Old Warehouse circa 1878.

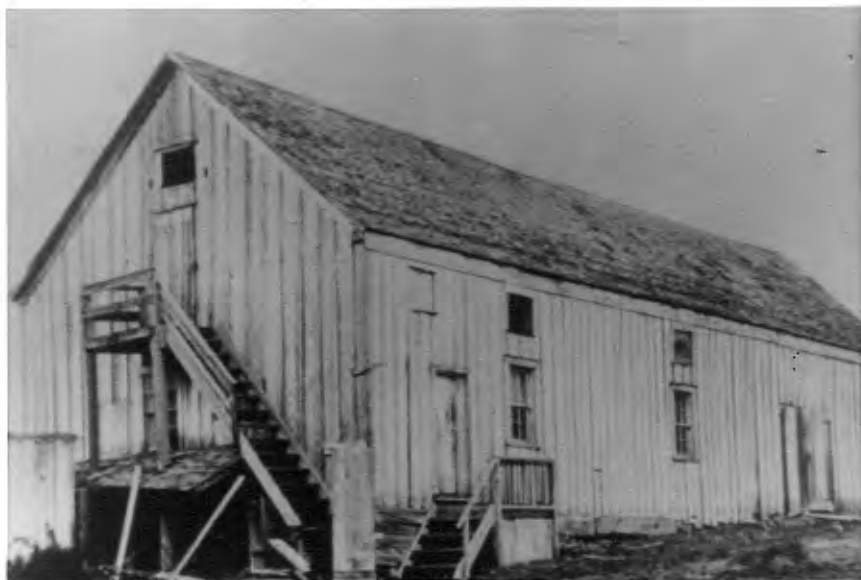
Figure 8. Photo of the Old Warehouse circa 1890

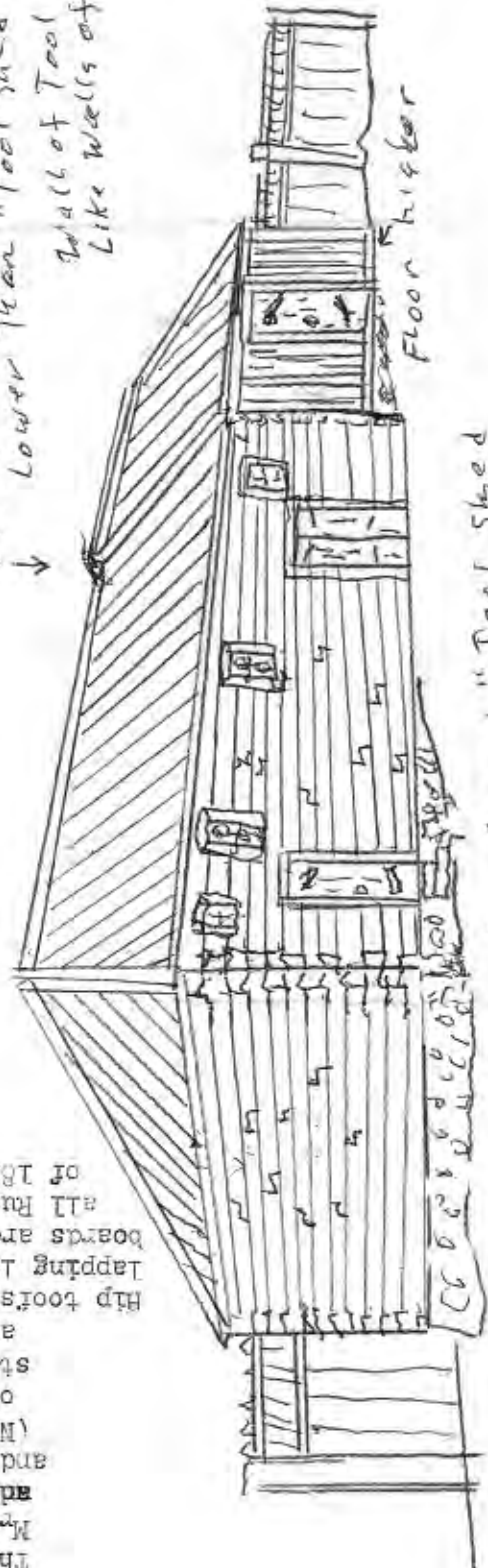
note "Fur Barn" roof slightly
 Lower than "Tool Shed" Roof,
 Wall of Tool Shed
 Like Walls of Church

The "Fur Barn" and "Tool Shed"
 with Traditional Hip Roofs.
 Based on proportions copied
 from an old photograph, I have not found
 those details.

Regarding the authenticity of the details of the Fur Barn: Every drawing of the fort which I have seen done during the 1812-41 period indicate a large building at this site and all show a "hip Roof". I haven't been able to determine if the building had one or two stories. The "Tool Shed" at the north end of this building is clearly shown similar in construction to the walls of the Chapel and barracks building. Archaeology at the site of the "Fur Barn" confirms that a large building once here. Trade goods and other small trade items have been found on the site. Traces of an old log wall have been found. Old drawings and photographs show ~~the~~ vertical boards covering the exterior walls and a big exterior frame stairway at the south end of the building. Both features are contrary to Russian construction of the 1812-41 period at Ft. Ross. It is interesting to note that the logs on the east side of the Rotchev House were flattened to receive a layer of similar vertical exterior boards. So it is possible the Fur Barn was a log structure with a covering of vertical boards. The stairs at the south end of the Fur Barn is obviously made of milled lumber and is of questionable authenticity. Mr. C.A. Call told me that there was an internal stairway at the north end of the building. It met a door from the Fur Barn into the "Tool Shed". Such a stairway is consistent with stairs in the blockhouses. One of the Call sisters fell down this stairs and broke her arm as a child. All the roofs on this building are indicated to be grooved long boards overlapping from the eave to the peak of the roof in two layers. These grooves were up to two inches wide and 3/4 of an inch deep in original roof boards. Note that the windows and doors indicated on the east side of the Fur Barn appear to be of a different design than those suggested in the Rotchev House and the Kuskov House.

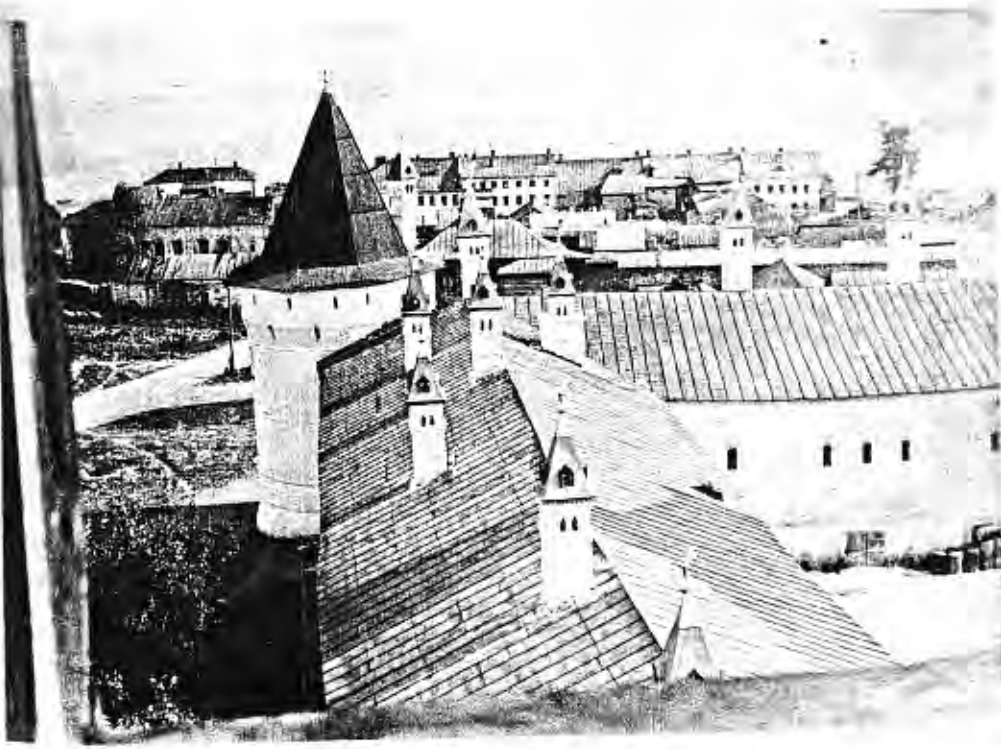
Fig. 63

* Note widely spaced ridges (standing seams) running perpendicular to the ridge of the roof.

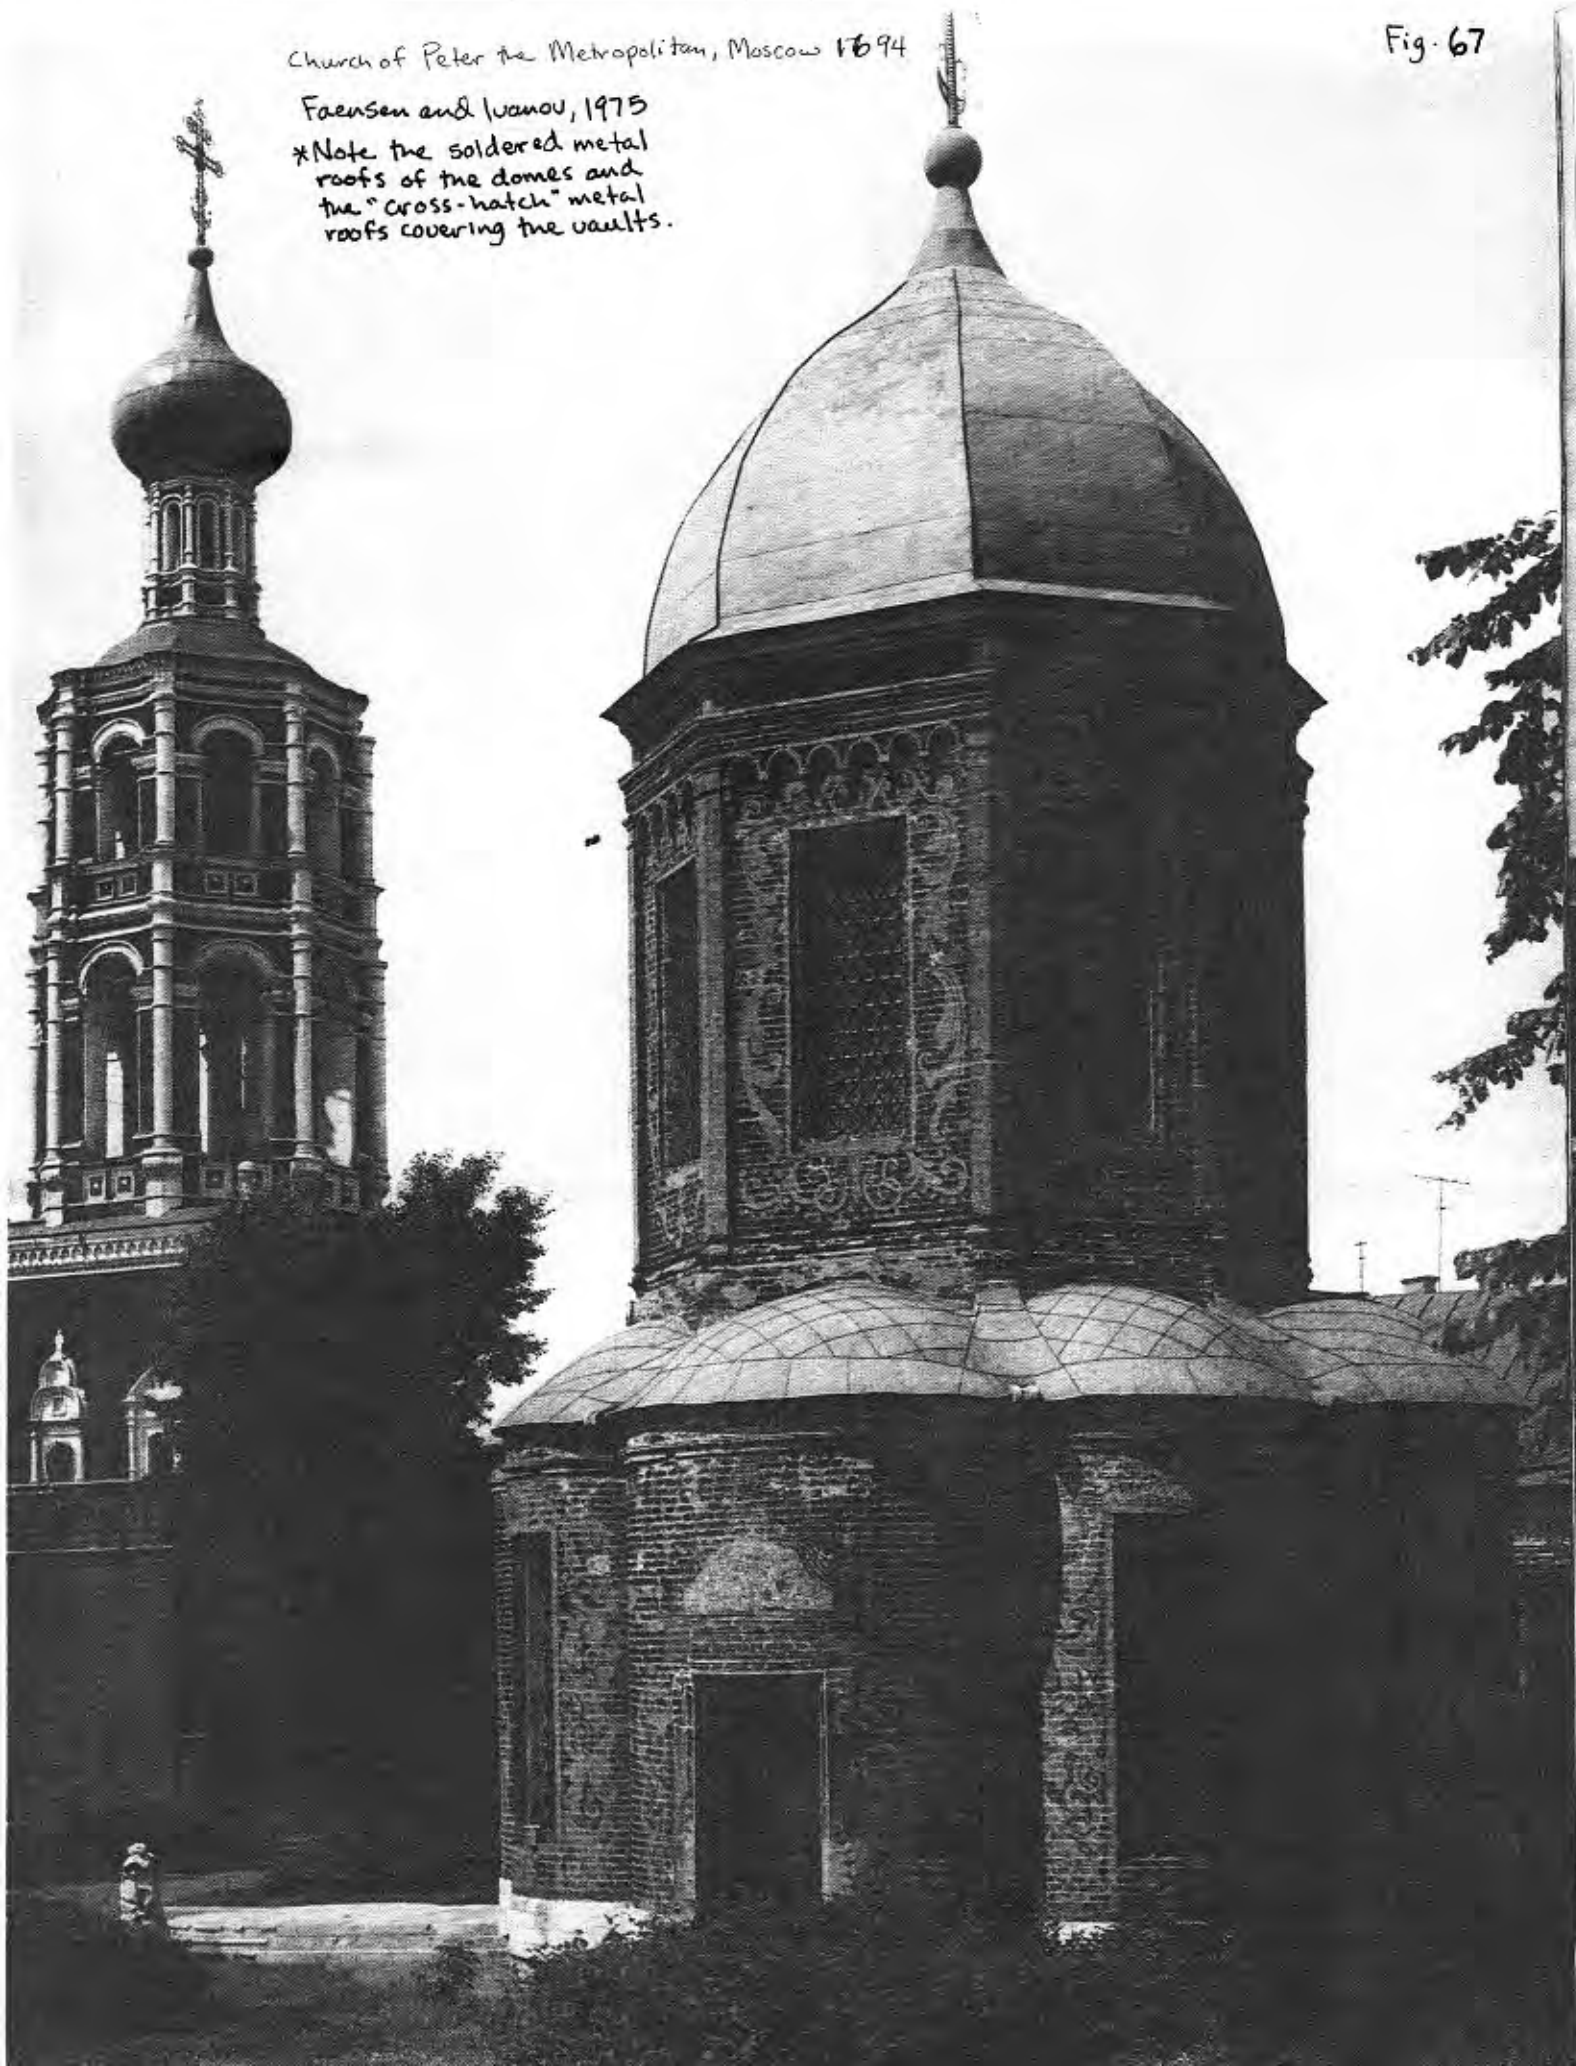
Fig. 67

Faensen and Ivanov, 1975
*Note the soldered metal
roofs of the domes and
the "cross-hatch" metal
roofs covering the vaults.

Standing seam metal roof
with plates laid on in
parallel rows.

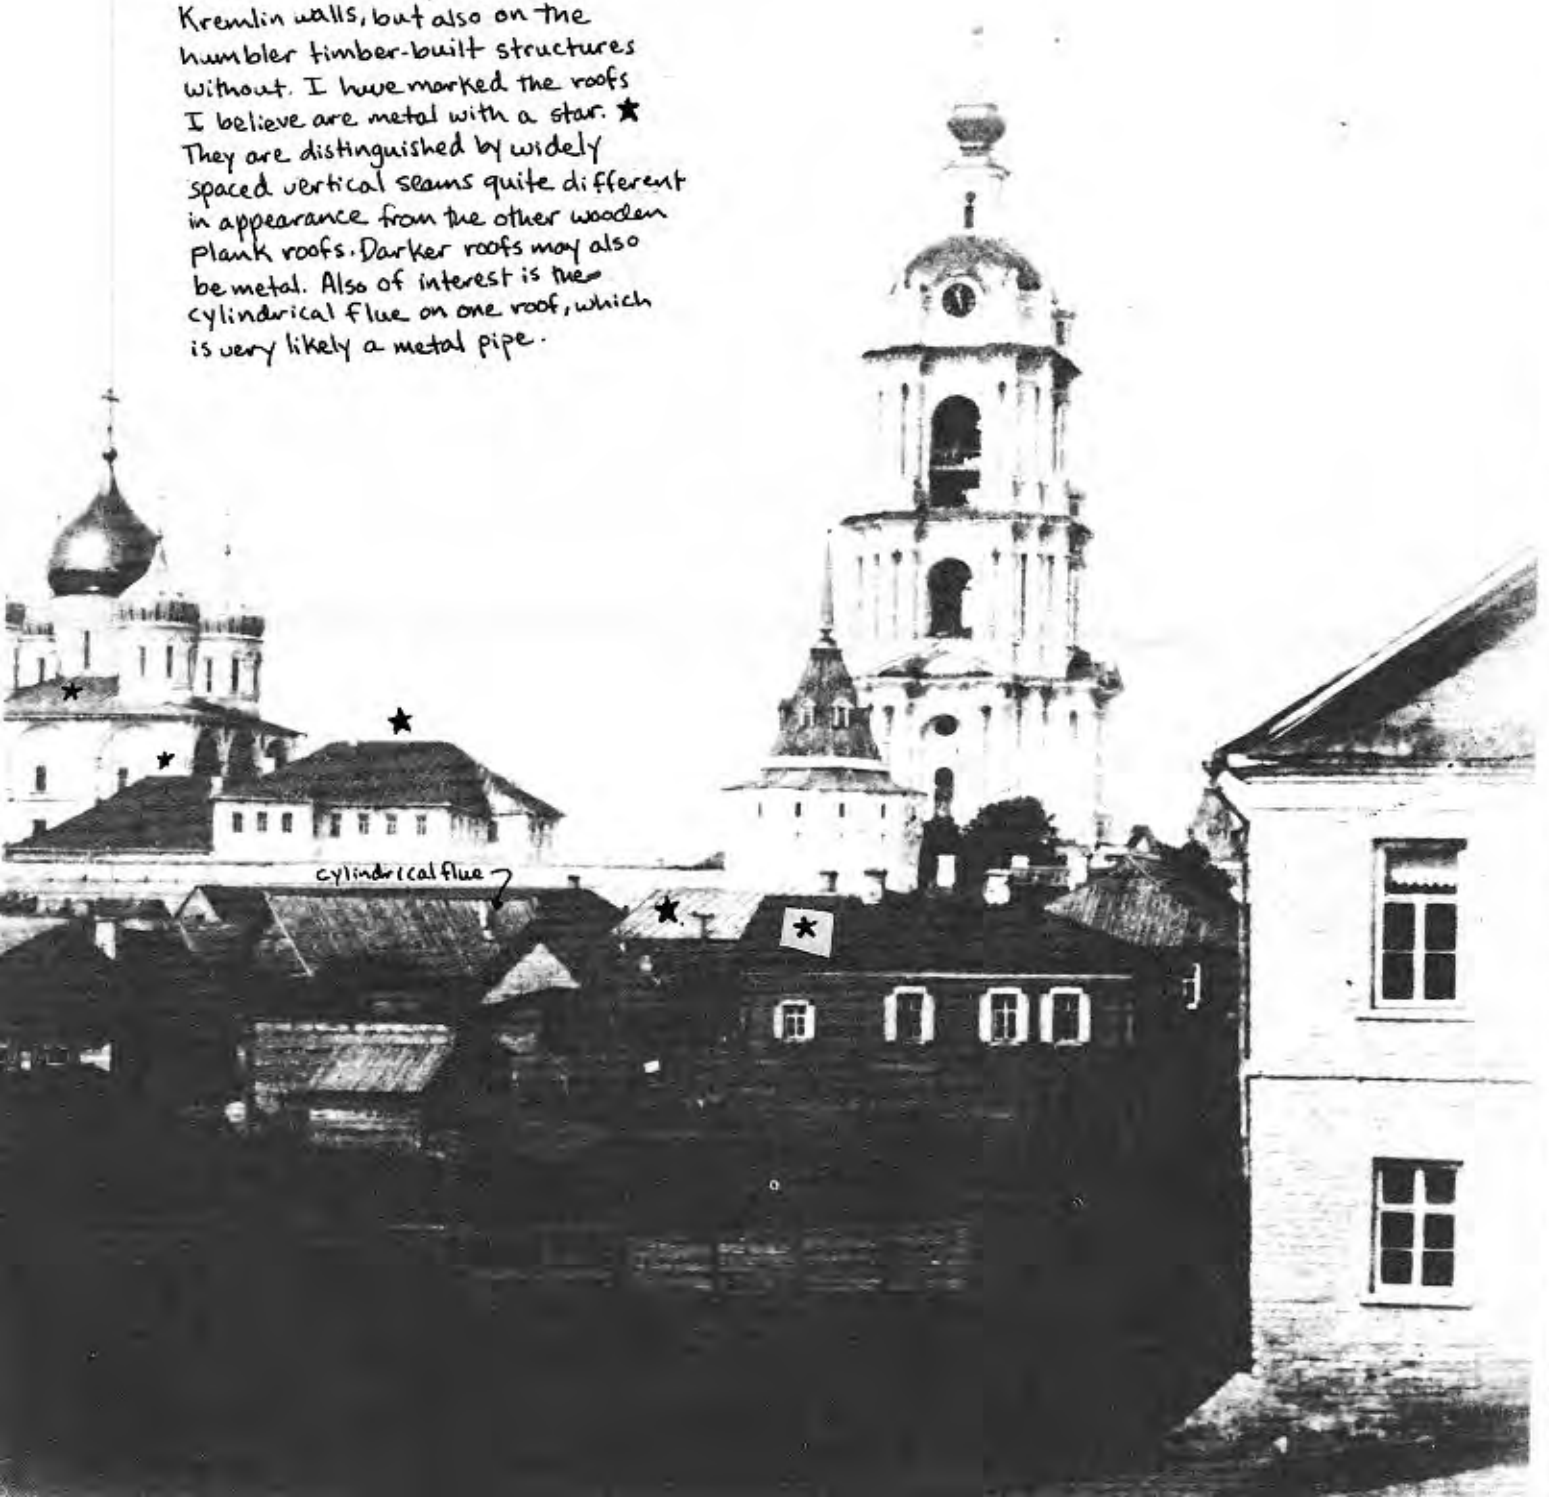
* Moscow, 1852

A close inspection of this photo reveals the use of standing-seam metal roofs not only within the Kremlin walls, but also on the humbler timber-built structures without. I have marked the roofs I believe are metal with a star. ★ They are distinguished by widely spaced vertical seams quite different in appearance from the other wooden plank roofs. Darker roofs may also be metal. Also of interest is the cylindrical flue on one roof, which is very likely a metal pipe.

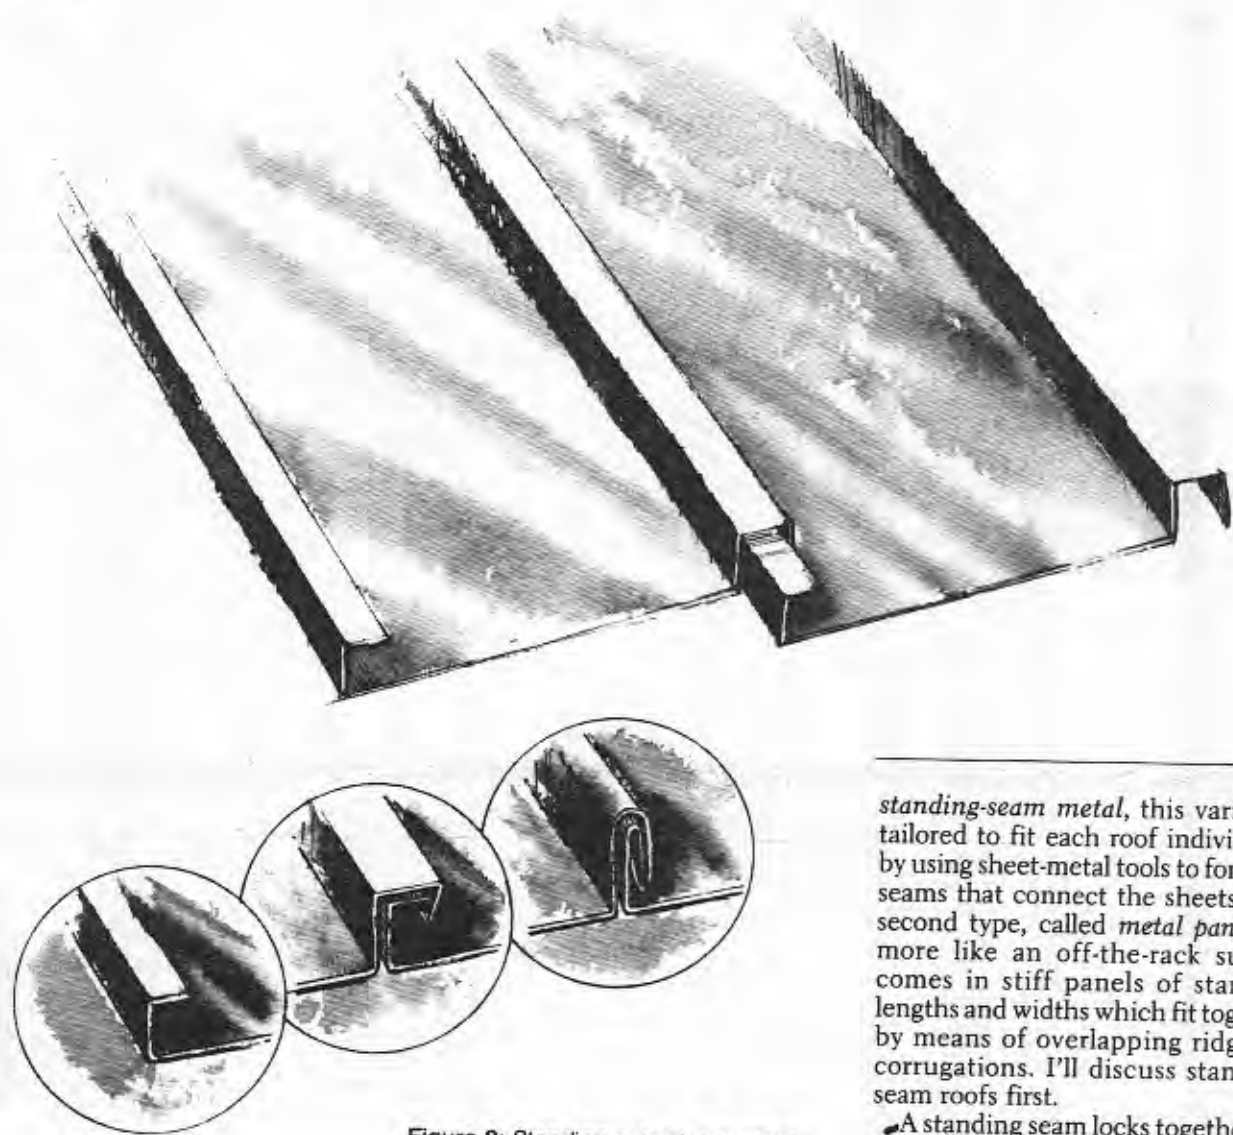
Figure 8: Standing-seam terne metal roofing

• A standing seam locks together the edges of adjoining sheets in tightly crimped vertical folds [Figure 8]. Because rainwater never sits over the seams themselves, running instead along the troughs between them, the possibility of leakage between sheets is virtually nonexistent. There is also little chance of leakage through holes in the sheets; the roofer secures a standing-seam roof to the deck by driving the nails through underlying *cleats* rather than through the surface of the roofing material.

standing-seam metal, this variety is tailored to fit each roof individually by using sheet-metal tools to form the seams that connect the sheets. The second type, called *metal panels*, is more like an off-the-rack suit: it comes in stiff panels of standard lengths and widths which fit together by means of overlapping ridges or corrugations. I'll discuss standing-seam roofs first.
