Title: Bricks and Fragments from Fort Ross Officials' Quarters

Author (s): Carol Hulquist

BRICK - OFFICIALS QUARTERS
FORT ROSS SHP

BRICKS AND FRAGMENTS FROM FORT ROSS OFFICIALS' QUARTERS

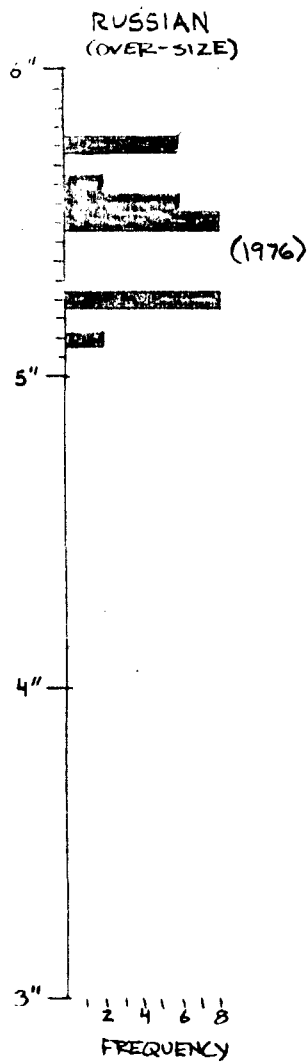
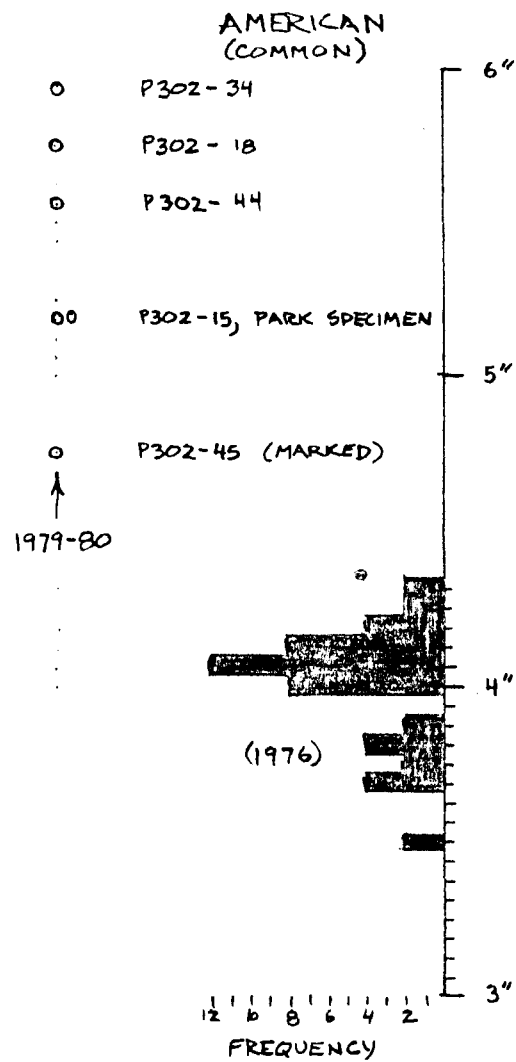
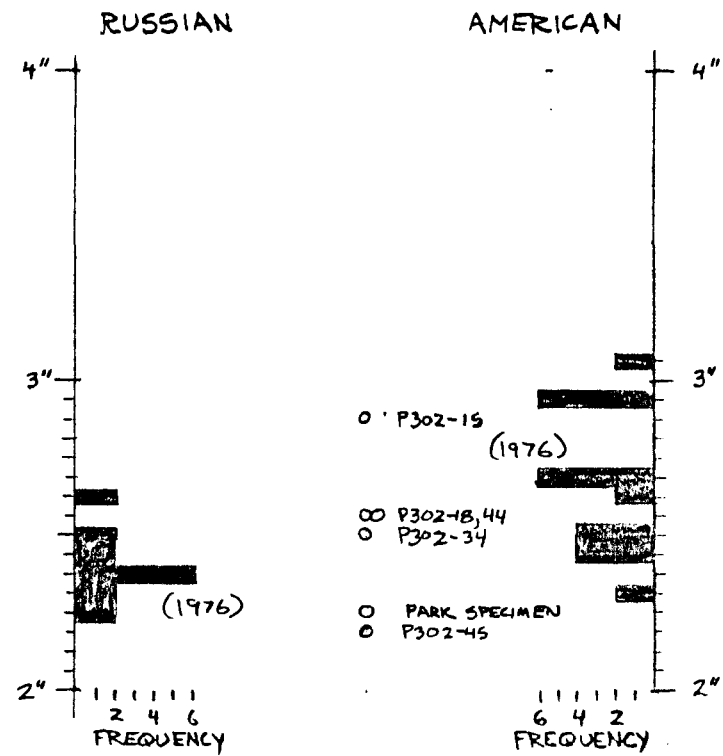
TABLES 1 AND 2 - COMPARISON OF DIMENSIONS OF PRESUMED RUSSIAN (OVER-SIZED) AND AMERICAN (COMMON) BRICK FROM THE "OFFICIALS QUARTERS" SITE, FORT ROSS STATE HISTORIC PARK, CALIFORNIA
(1979-80 DATA ADDED TO ORIGINAL 1976 TABLES (HULQUIST 1977)
(LENGTHS NOT AVAILABLE - MOST INCOMPLETE)

TABLE 1 - WIDTH

TABLE 2 - THICKNESS

One specimen (p. 302-45) is marked with a large "X"; it is somewhat smaller than the other presumed Russian bricks, but wider than the American bricks listed in the 1977 report. A sketch of this brick is enclosed, as is a table comparing the 1976 and 1979-80 bricks (p. 302-15), is almost complete, although its full length still cannot be measured. I have also included the dimensions of the only intact "Russian" brick I know of. Its original provenience is unknown; it is housed in the Park Office at Fort Ross. I suspect that we will find that these bricks are approximately twice as long as their width.

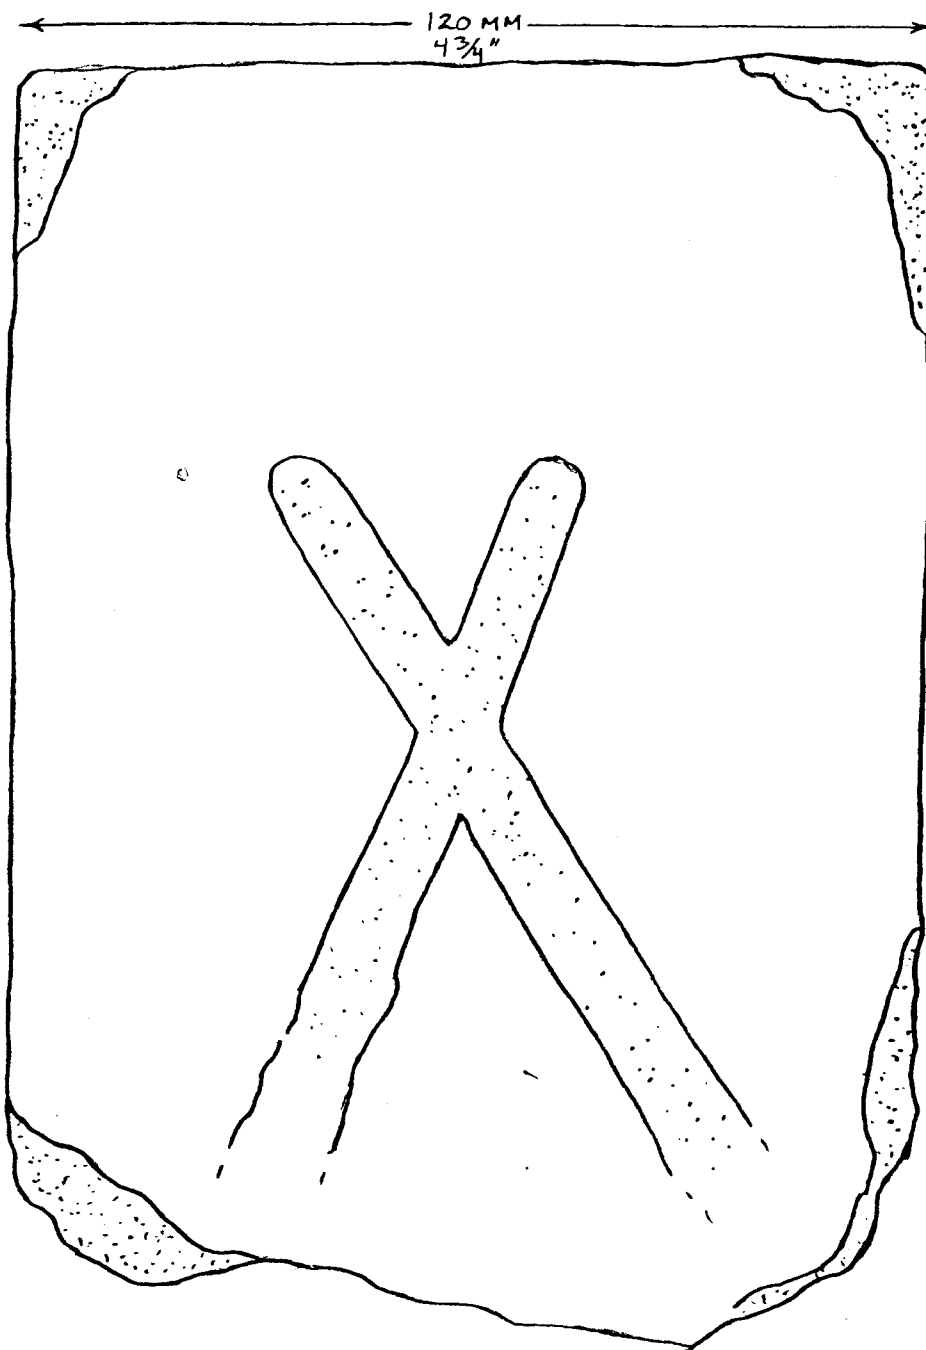
P302 - 45

MARK - SQUARE SIDED IMPRESSION
~ 3-5 MM DEEP

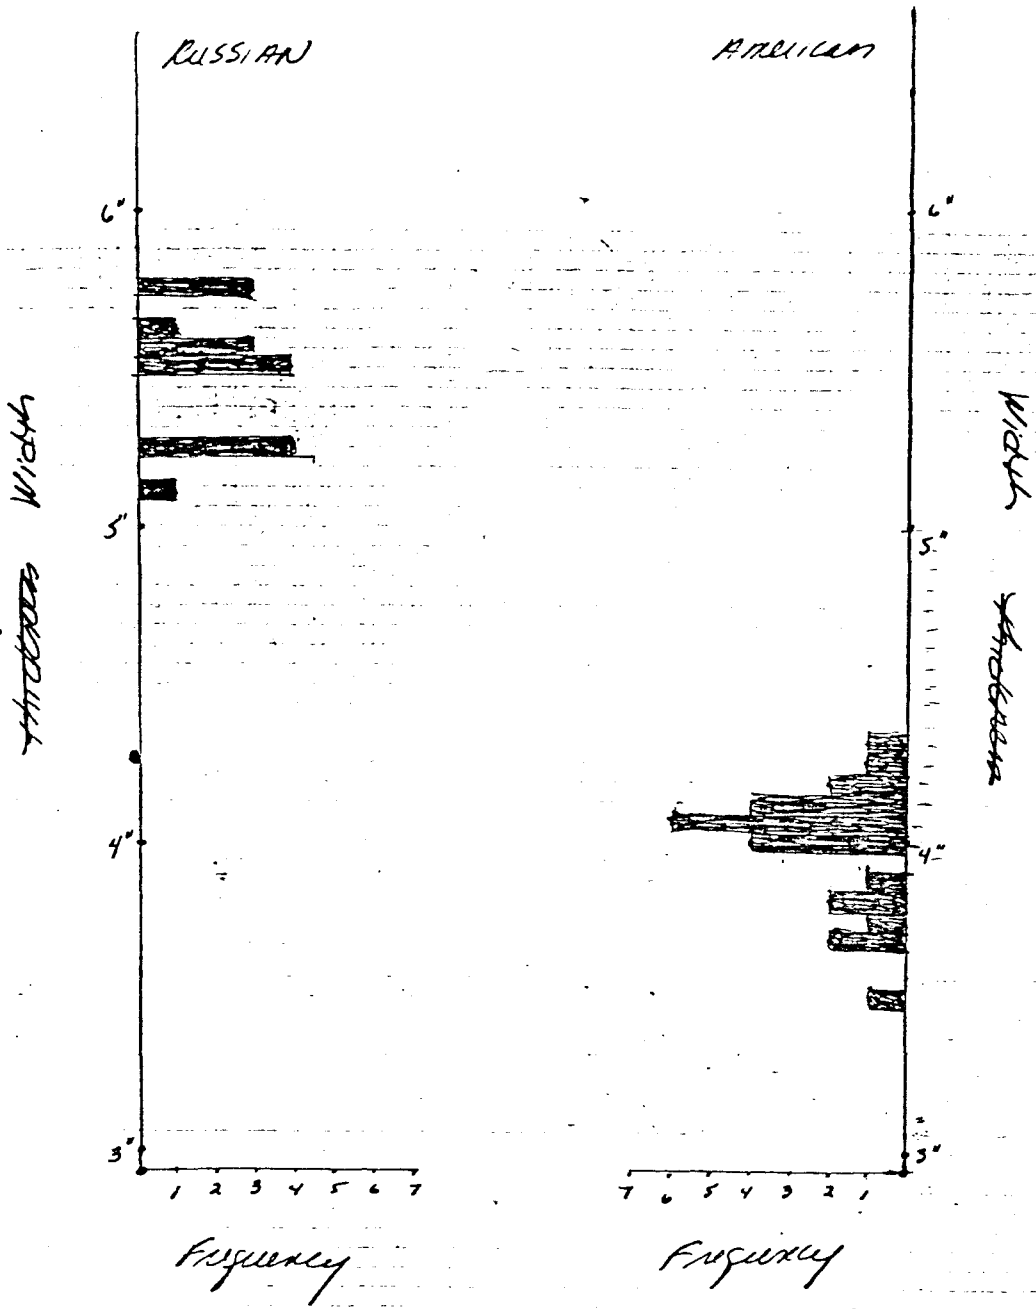
Table 1.

Comparison of US American Widths ~~with~~

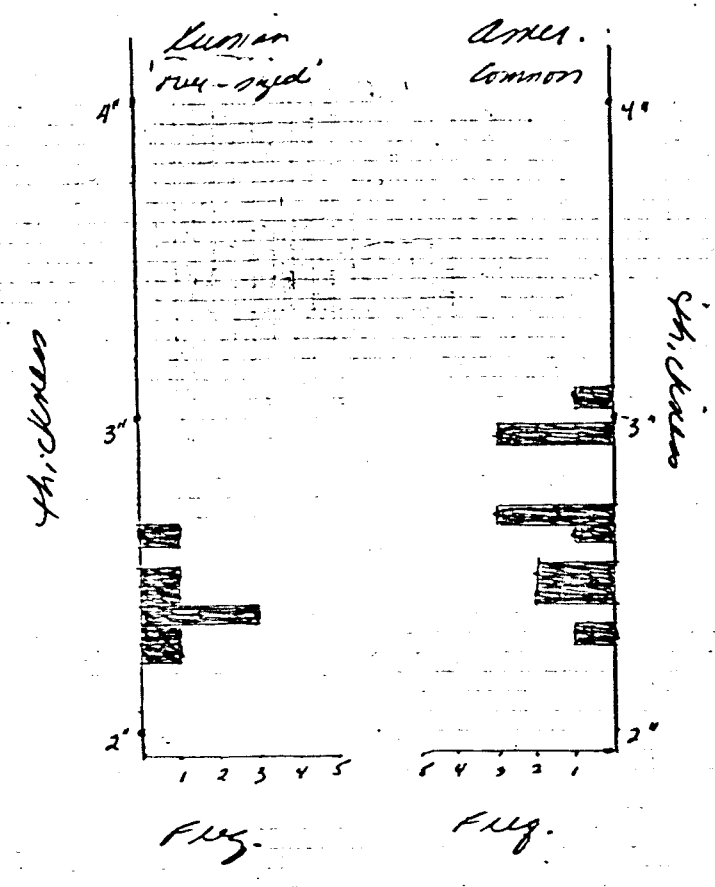
Table 2. *Ruminant vs. ~~Amel.~~ Amel. - thickness - ~~Table 2~~*

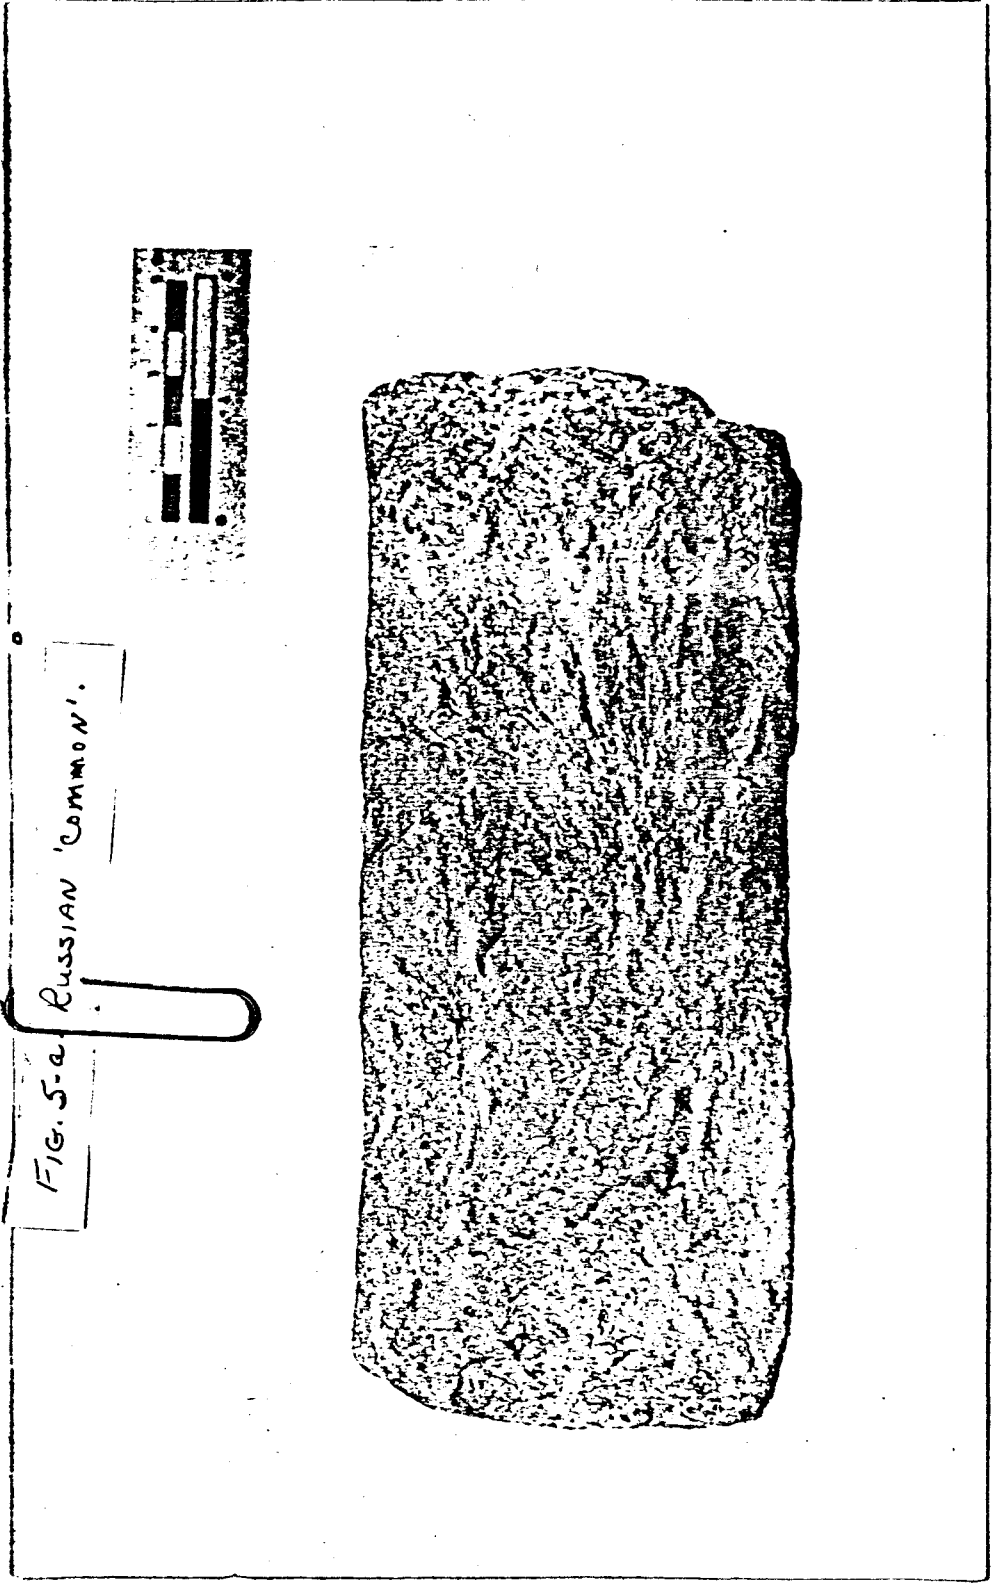
FIG. 5-a. RUSSIAN 'COMMON'.

Bricks of special shapes and sizes were also made for special functions, such as arches, chimney shafts, and lintels. From the Officials' Quarters area seven arch bricks were recovered as well as two "roman" bricks, two "roman arch" bricks, and one keystone brick (See Figure 5). Undoubtedly some of these ^{were} ~~were~~ used in the construction of the Russian stove.
