PRELIMINARY REPORT OF THE 1981 EXCAVATIONS  
OF THE FORT ROSS FUR WAREHOUSE

GLENN J. FARRIS, STATE ARCHEOLOGIST I  
CULTURAL RESOURCES MANAGEMENT UNIT  
RESOURCE PROTECTION DIVISION  
CALIFORNIA DEPARTMENT OF PARKS AND RECREATION

September 1981

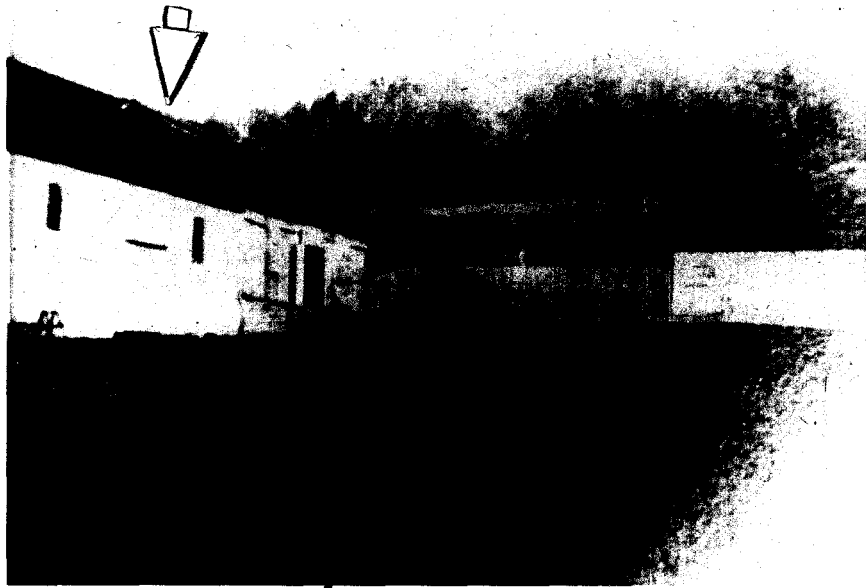
Figure 7. Photo of the Old Warehouse, circa 1878.

This notion is supported by a drawing dated September 1878 which shows two different buildings joined into one structure (O'Brien 1980:end cover illustration). We also have a photo which shows the same structure, but the date on this is uncertain (Figure 7). What is very interesting is that circa 1890 there is yet another photo of the building which seems to show the northern addition to be missing (Figure 8), and yet a survey made of the buildings on the Call Ranch by Frank B. Veasey in 1892 shows the building in that location to be 80 ft in length and 28 ft in width.

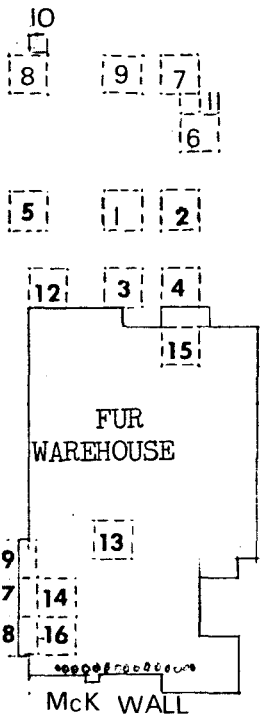
FORT ROSS FUR WAREHOUSE 1981 EXCAVATION PROJECT

Numbered squares are Cabrillo College excavation units—1975, 1976, 1977

Solid line encompassing the Fur Warehouse shows 1981 excavation area

BM=USGS Bench Mark

SCALE: 1 inch=10 meters

The first step in the archeological work on the Fur Warehouse was to re-establish the metric grid first worked out for the fort as a whole in 1975 by archeologists from DPR. This grid is oriented using a grid north which is actually 26.5 degrees east of true north (and currently 8 degrees east of magnetic north). The center of this grid is a brass-capped USGS bench mark located near the southern gate to the fort (see Map 1).

The grid location for the Fur Warehouse was pinpointed using a transit and a 60 m tape. The next step was to relocate the excavation units dug by Cabrillo College in 1975-77. These were marked off, but generally not excavated as it was felt that the earlier excavation notes were sufficient. However, where re-excavation appeared likely to yield valid information, this was done. The correlation of the new grid with the old was surprisingly good, with no more than a 3 cm variation in the north lines and a 1-3 cm variation in the west lines. All of the excavation work fell in the northwest quarter of the fort grid area; therefore, all unit designations will appear with an N (north) and a W (west) followed by a metric unit showing the distance from the bench mark central datum point (example, N62 W44). Since Cabrillo College had done so much work in the north end of the overall area, it was decided to begin the current excavation work immediately south of their Units 12 and 15 (Map 1) so as to follow the apparent remnants of the east and west wall lines.

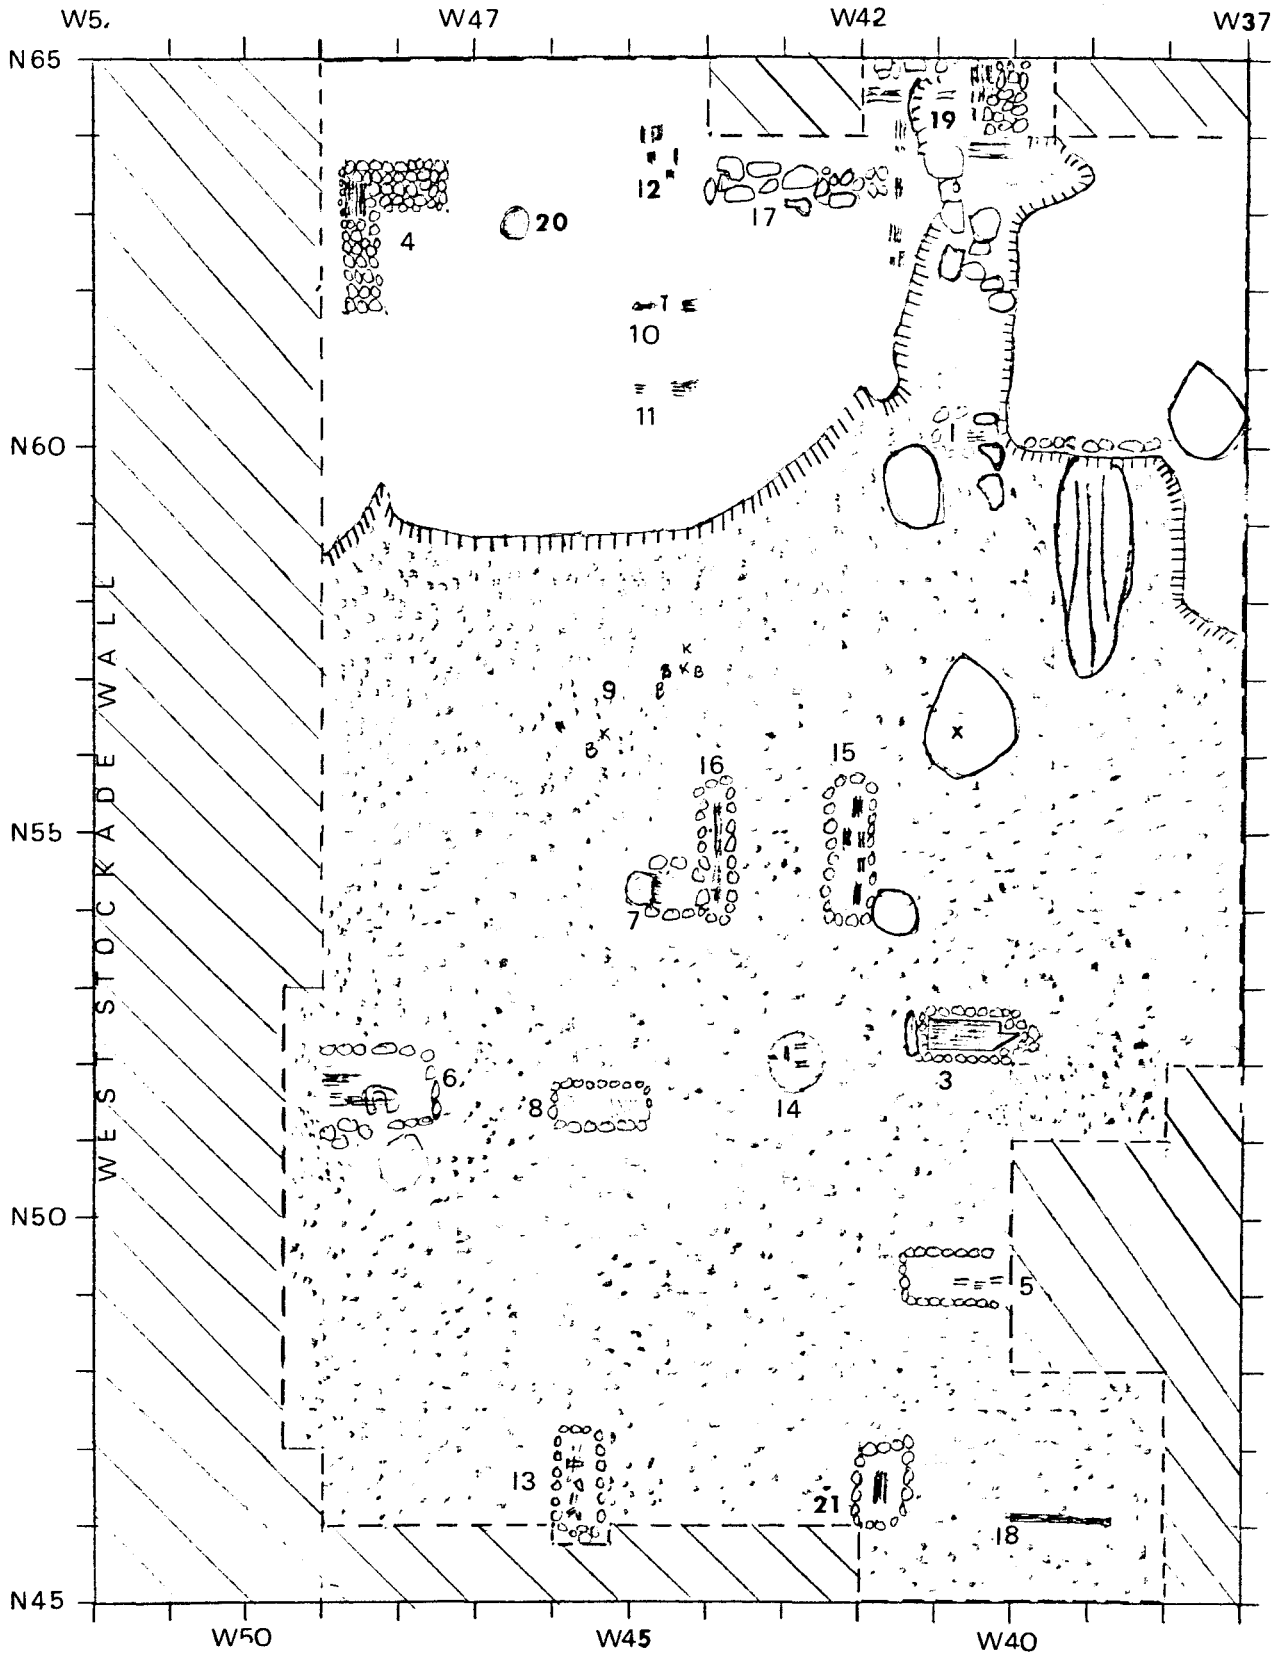
MAP 2

**KEY**

- rocks ○
- rocky fill
- feature number 6

- wood
- unexcavated area
- limit of rocky fill and bedrock

Perhaps the most important feature discovered was an L-shaped placement of stones (Feature 4, see Figure 9) which had filled a pit of the same shape dug into the earth. Its grid location is N61.68-63.72, W47.3-48.7) (see Map 2). I believe this to be a foundation for the northwest corner of the original Russian structure. Immediately overlying part of the western portion of the feature is a 3 in thick, 10.6 in wide redwood board which is lying on the line of the west (or rear) wall. Whether this board truly dates back to the Russian period is uncertain, but I think unlikely. It most probably is

East of the northwest corner feature and running in line with it is a crude assemblage of large (ca. 30-40 cm diameter) stones (Feature 17) found in the area N63.15-63.70, W42.0-44.13) (Map 2). The stones are sitting relatively high, being pedestaled on the loamy soil rather than sitting on the clay subsoil. The surface of this line of rocks is a good foot (31.5 cm) above the rock level of the northwest corner rock feature. I, therefore, question whether it is associated with the original Russian structure. More likely, it is tied to a later, extended building constructed over the earlier one. The higher level implicit in this line of stones would be more in keeping with a higher floor level dictated by the upslope end of the 80 ft building.

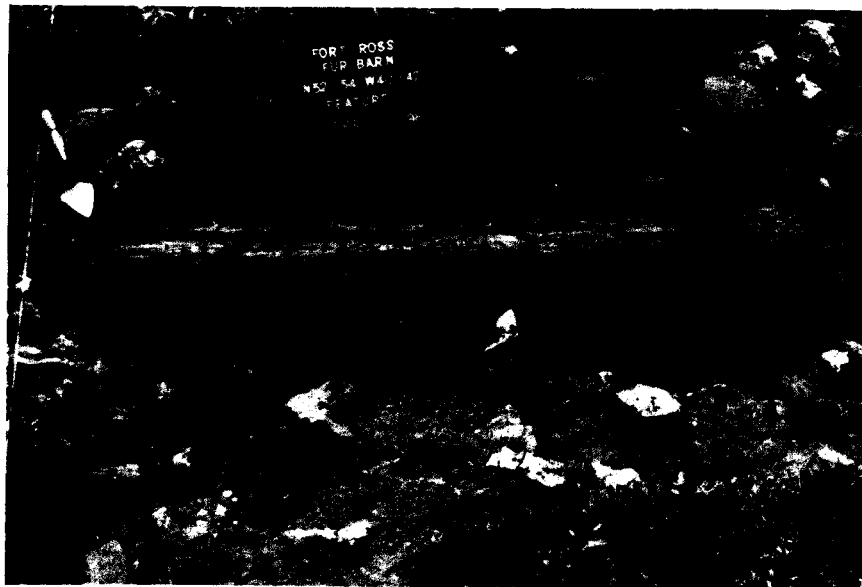
Figure 12. Wooden "Sleeper" (Feature 3) Along East Wall Line.

Feature 3 (Figure 12) is a redwood board 1.2 m (47 in) long by .36 m (14 in) wide and ~~0.075 m~~ <sup>0.075 m</sup> (3 in) thick. This is oriented east-west and lies in what appears to be a purposely-constructed trough in the rocky fill. The board lies within the parameters N52.21-52.63, W39.96-41.20. The shape is somewhat curious. Although it has a fairly straight cut across the west end, its east end has a long diagonal cut combined with a notch. This piece was discovered to be in remarkably good condition which made it quite different from most of the rest of the wood found in the site. This is apparently due to a pitch material which coats the two cut ends to a thickness of about 1 cm. I thought at first that pitch might have been applied but was corrected by Mr. Emmet Crisp, a veteran log worker, who suggested that the wood had been cut and laid in "green" and the coating was an exudation from the wood itself. When the elevation was measured for the east and west ends of this sleeper, it was found that the east end was 7 cm (3 in) lower than the west end. This had caused me concern until I developed the hypothesis that the board was used to support a vertical column of the gallery which is said to have occupied the east side of the structure. Presumably, the extra weight on the east end resulted in that end being lower. The center of what I believe to be the load-bearing portion of the log is at N52.4.
