Title: Some Points of Interest at Fort Ross, 1948

SOME POINTS OF INTEREST

FORT ROSS

STATE HISTORICAL MONUMENT.

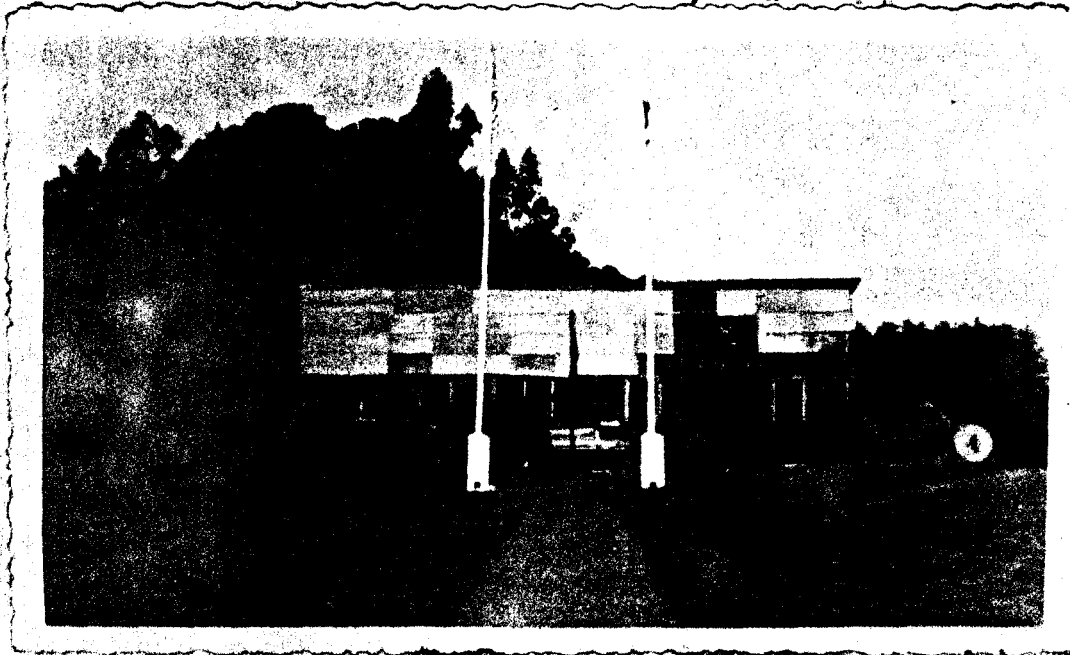
THE COMMANDER'S HOUSE, FORT ROSS

The Commander's house is the only large log building of the Russian period which now can be found at Fort Ross. From the records of those who visited Fort Ross during the Russian occupation, 1811 to 1841, it seems that this building was one of the most ornately furnished buildings in the whole of California. There were tapistries on its walls, the finest of carpets covered its floors. The furniture was that of a princess. In the pantry was cut glass and silver and service equal to any in Europe. The possibilities for entertainment and comfort in this building must have seemed beyond belief to the early guests at Fort Ross.

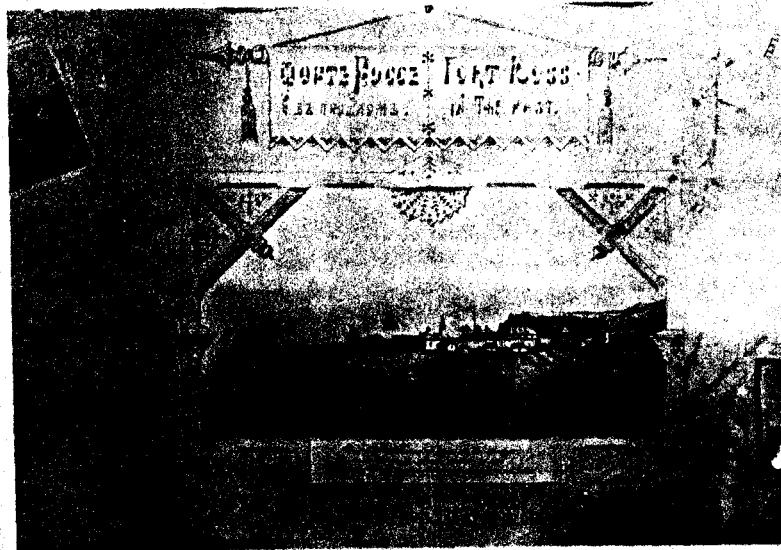
A view from the east drawn by the French explorer Dahout-Cilly about 1835 and appears in "Voyages Around the World. Paris. 1835.

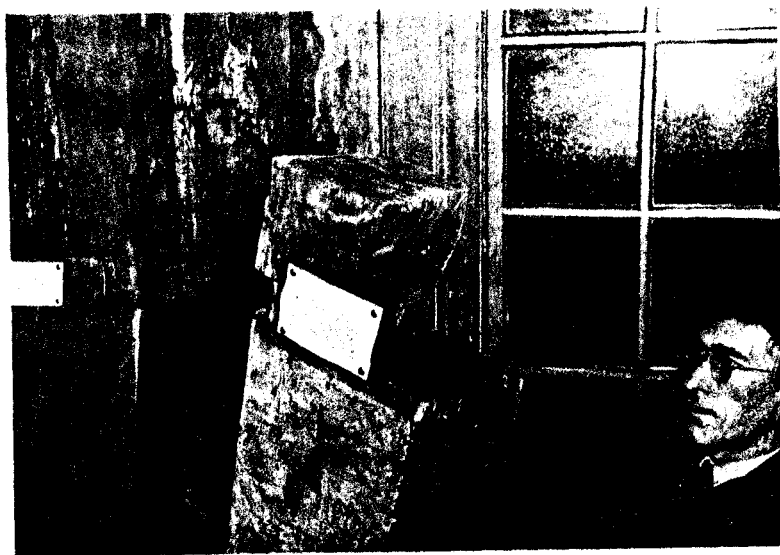
The picture here gives some idea of the key and dove-tail cut. This view shows the painted inside surface of a wall log and its lower surface detail. The notch to the left of the card is the narrow end of the wedge cut to receive the key in the next log.

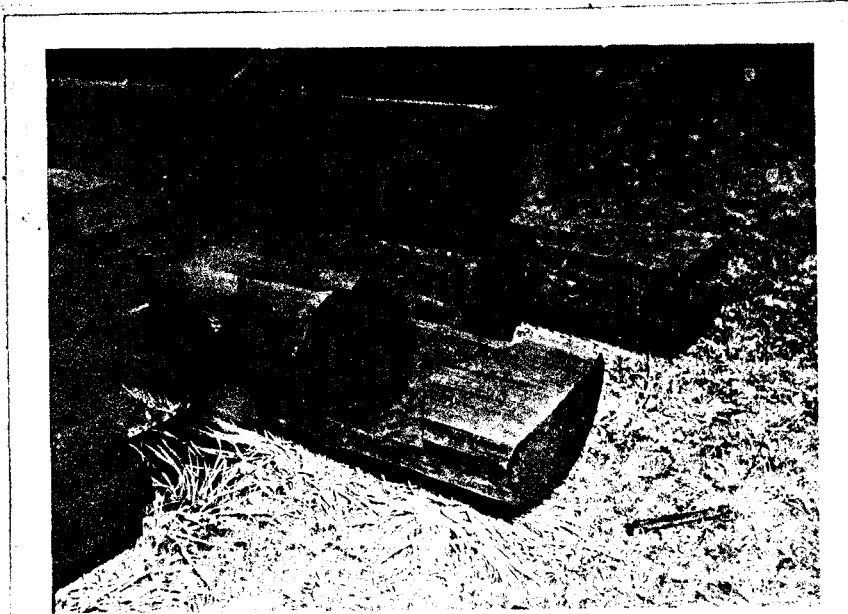
This picture has several points of interest. The large log in the foreground is inverted as regards its position in use. Note the groove which is typical of the lower side of most wall logs. The cut with the triangular faced step is the upper half of an end to end lock joint. This was used to tie the first and last logs in the long side walls of the Commanders house. Thus the problem of tying the wall together was solved. The flattened log in the background with the large groove illustrates one half of the most common end to end log joint used in the walls of this house. Its chief claim was simply that it kept the logs from rolling. When window or door openings were made a tongue was left in each log and the window frame was grooved to anchor the logs.

In the center of the picture is a log which has been shaped out to receive the ends of log used as the face and rise of a stairway on the outside of the building.

(The peculiar spots on the plate are probably due to an accident in developing and show incomplete solution of developer crystals.)

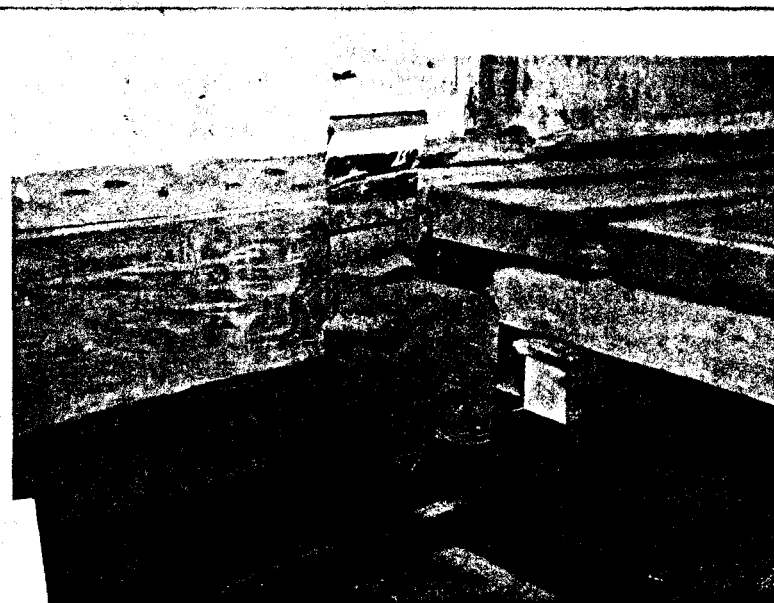
This is a cross-section study of original flooring as found in the Commander's House. The boards shown here are 15, 18, and 26 inches wide respectively and 4 inches thick, especially at the end of each board and at points where the board crosses a floor joist. The lower side is often left rough as slip.

The average board is about 20 inches wide. The rabbeting along the edges overlaps from  $1\frac{1}{2}$  to  $2\frac{1}{4}$  inches and is quite well-done.

Some partitions reset directly on the flooring and the door frames were tenoned into the floor. The presence of the old mortis scars may assist in locating some of the original partitions.

The picture on the right shows the way the floor joists were framed in. The notched log in the center does not support the floor but seems to be a cross tie to hold the log wall in place.

The lower limits of the white calsimine may indicate the level of the old floor or the top of the mold board. The reason for the patched hole above this joist has not been determined.

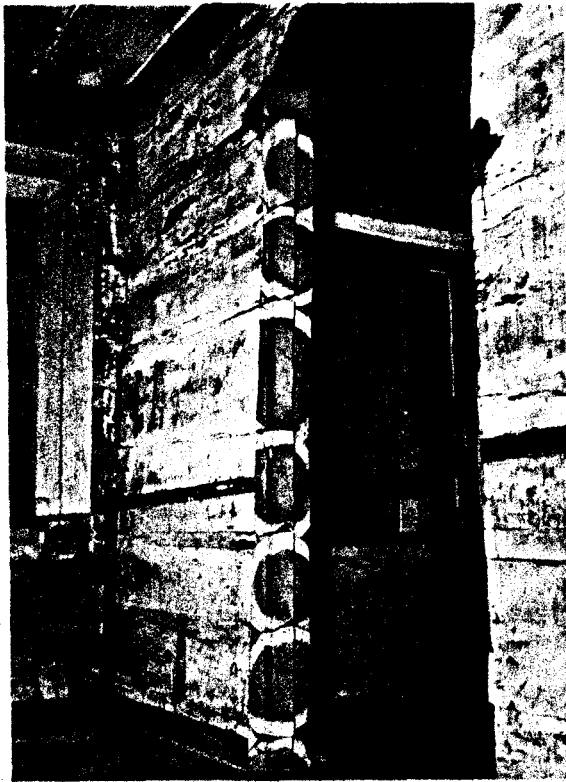
This picture shows the cuts needed to put a doorway through an interior log wall, in this case. The detail is also true of the other doorways through log walls, in the Commanders' House. The tongue shown on the sides of the opening fit into the groove mentioned on the side of the door frames. The extreme height of the opening is necessary to allow the header to come down on the tenons which rise from the frame. As in the window frames a wide shim is driven into the resulting opening above the header, one from each side of the wall, and wedged tight.

The lighter colored rings of wood in these original logs is the sapwood. This doorway is not original but a later mutilation which requires restoration in the pattern of an original doorway.

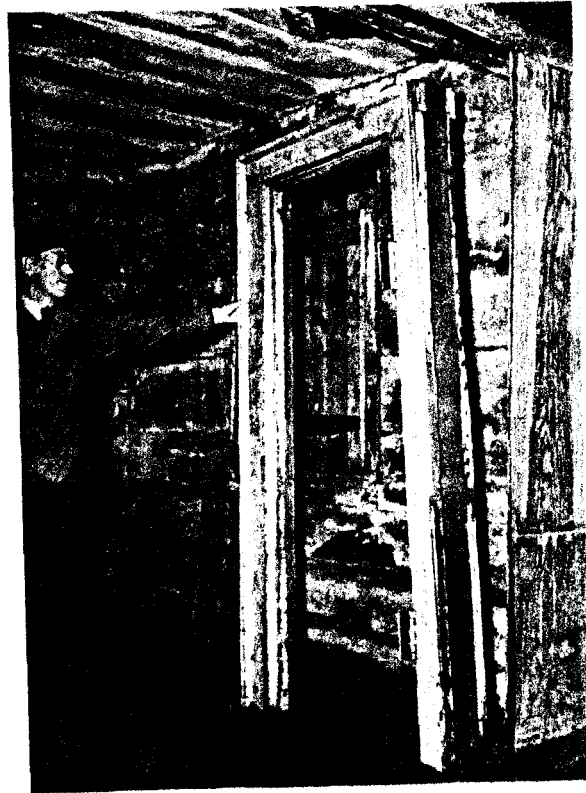
### An Original Door Frame.

The opening is 78 inches high and 28½ inches wide. The frame is made solid and held together by a set of mortis and tenon joints and bevels. Each side of the frame is tenoned into the floor. Down the side of each frame is a plow 3½ inches wide and 1½ inches deep into which the edge of the partition or the ends of logs are made to fit as a tongue. Thus anchoring the wall. The widest dimension of the frame is 7" by 8". On the side away from the camera there is a steep bevel. The jamb is a solid part of the whole frame. The door fitted flush with the camera side of the frame as shown. The hinges do not have loose pins, are iron and wing-type, 6" long with 4" wings, and secured by screws.

This figure shows the detail of the joining of the sides and header of both door and widow frame. Note the groove and the bevel shown. The header is on the right. The typical mortis and tenon joint is seen center.

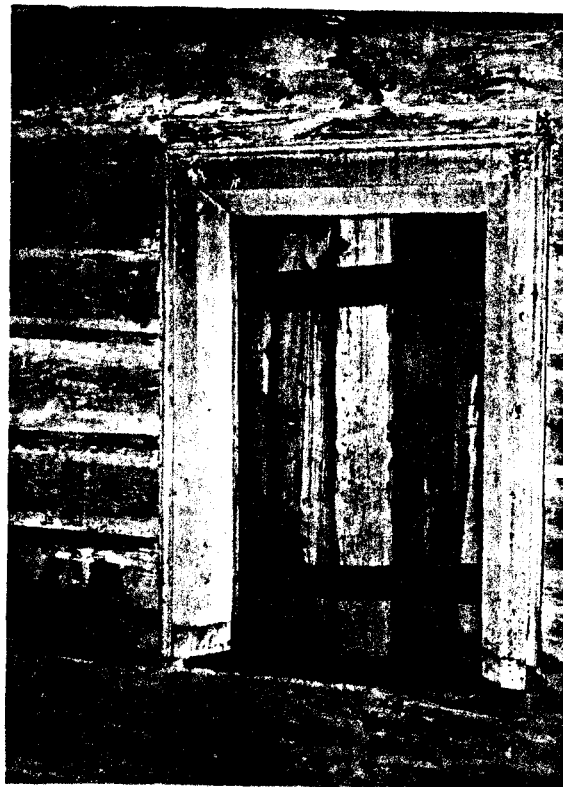
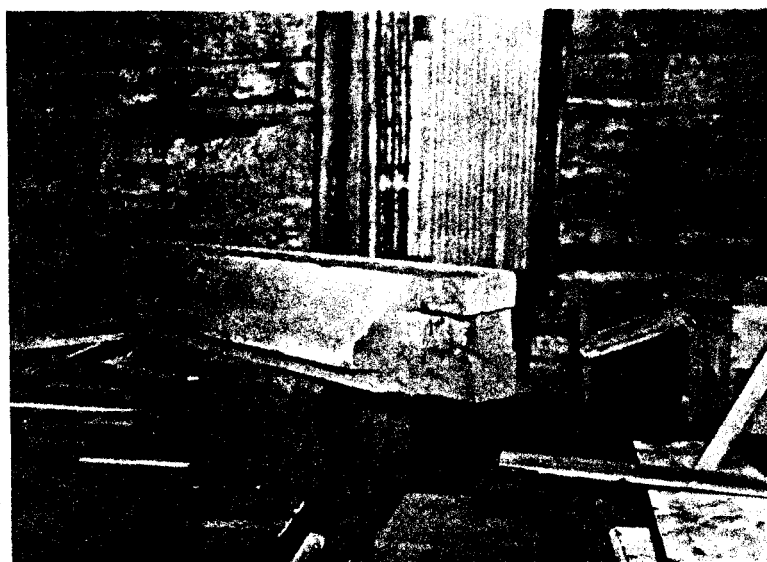
This shows an original window frame in place with the old molding. The sill has been cut through in later mutilation. Note the deep bevel. There is a  $1\frac{1}{2}$  in. rabbit on the outside which forms the window jam. All joints are mortis and tenoned. The header is secured by the wide shim which shows above the top molding.

The picture below gives a better view of the detail in the header of the window and also the typical door frame. Notice the deep inside bevel, the rabbited window jam, and the mortis.

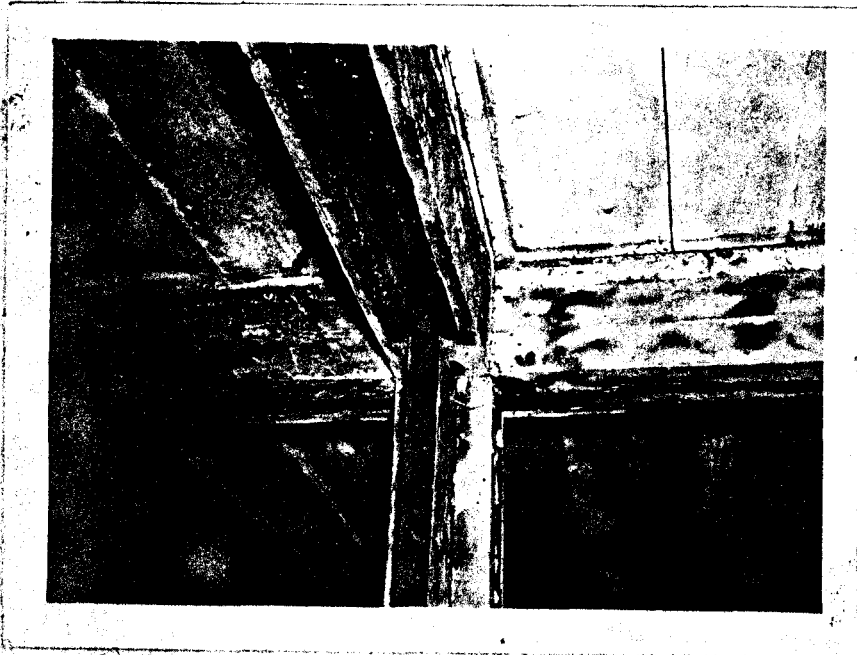
Here is shown the meeting of two ceiling beams and a pillar. All are deeply grooved to receive the boards of the wall in the interior of the Commander's House. This secured the top and sides of the wall boards. At the floor these boards ~~were~~ rested on the floor and were held in line by a three inch quarter round mold board, which in turn was daped into the wall log at one end and wedged in at the pilar end. Traces of the old wall paper and the tacks which held it may be seen in the picture.
