Title: The Chapel at Fort Ross: Its History and Reconstruction

Author (s): Diane Spencer-Hancock and William Pritchard

The Chapel at Fort Ross

Its History and Reconstruction

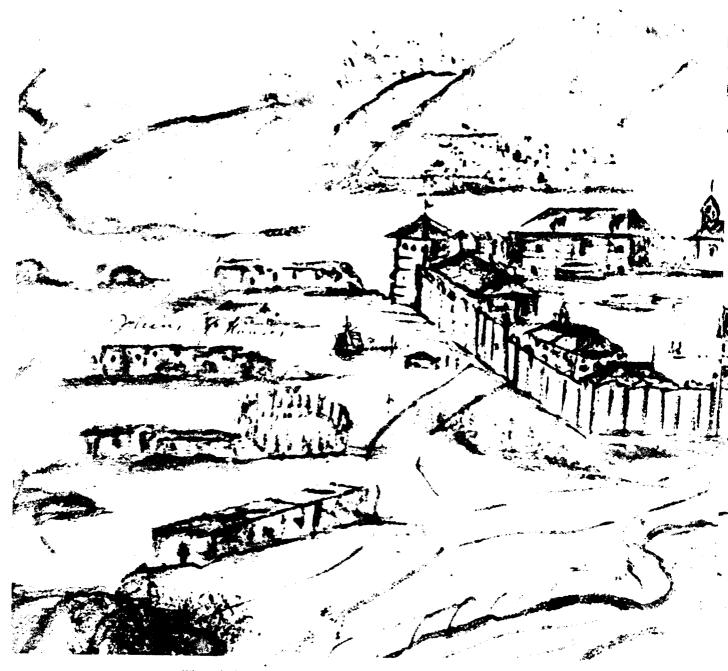
The only known historic sketch of Fort Ross at the time of its sale to John A. Sutter. This sketch was made by G. M. Waseurtz in 1842 and appeared in his manuscript A Sojourn in California by the King's Orphai

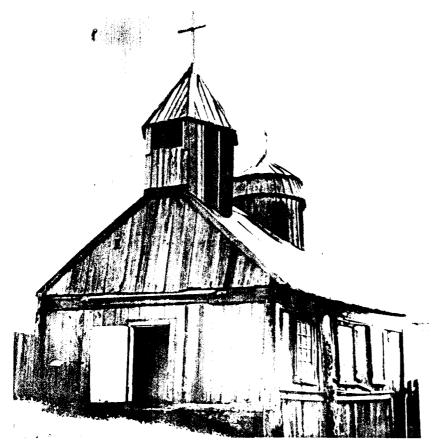
The Chapel following George W. Call's restoration in 1899. Note repair of roof area and replacement of broken windows. The original wooden lecturn and candelabra can be seen to the left of the door.

Mowever, by the late 1890s, George W. Call, istue, businessman that he was, recognized the value of the Chapel as a tourist or visitor attraction. A newspaper report of 1899 stated that Call had completed restoration activities on the Chapel. He Photographs of the period indicate that Call repaired in, belitower, cupola and roof, re-hung the door

and replaced broken windows. Further, he apparently made an attempt to gather together what he believed to be original furnishings of the structure. Two wooden pews found in the fur storage barn-cum-ballroom were returned to the Chapel, as were a lecturn and candelabra.

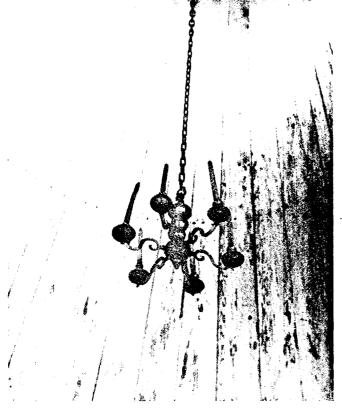
The original chandelier recovered by the Russian Orthodox community of San Francisco was reliung in the cupola following 1916 reconstruction. The photograph below shows the interior of the Chapel following 1916 reconstruction. Members of the Russian Orthodox congregation in San Francisco were by this time utilizing the Chapel for special religious observances.

the general public. Furthermore, following the building effort, members of the Russian Orthodox congregation in San Francisco began a tradition which survives to this day of observing special liturgical holidays in the Chapel built by their departed countrymen. Through their efforts, the original bell and original chandelier were found and replaced in the structure.

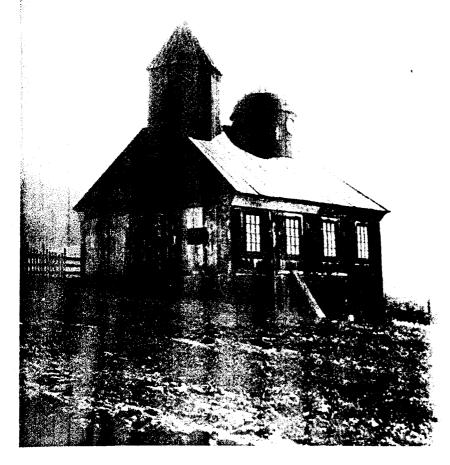
Chapel following the 1916 reconstruction. Note the four windows and side panels.

The 1916 reconstruction of the Chapel consisted primarily of raising the roof with the belltower and cupola intact and building a new system of walls and foundations. Unfortunately, in order to provide timber which would match the original wood of the Chapel, the equally ancient Officials' Barracks was demolished. Timbers from that structure were used as the main support of the reconstructed Chapel, while additional board lumber was obtained elsewhere for the roof and siding.

extra wall stud was needed for support. This increased the number of panels in the south wall to four and due to this configuration, four windows replaced the original three.
