ARCHAEOLOGY OF THE OLD "MAGASIN" AT ROSS COUNTER, CALIFORNIA

GLENN J. FARRIS

CALIFORNIA DEPARTMENT OF PARKS AND RECREATION

SITKA, ALASKA AUGUST 22, 1987

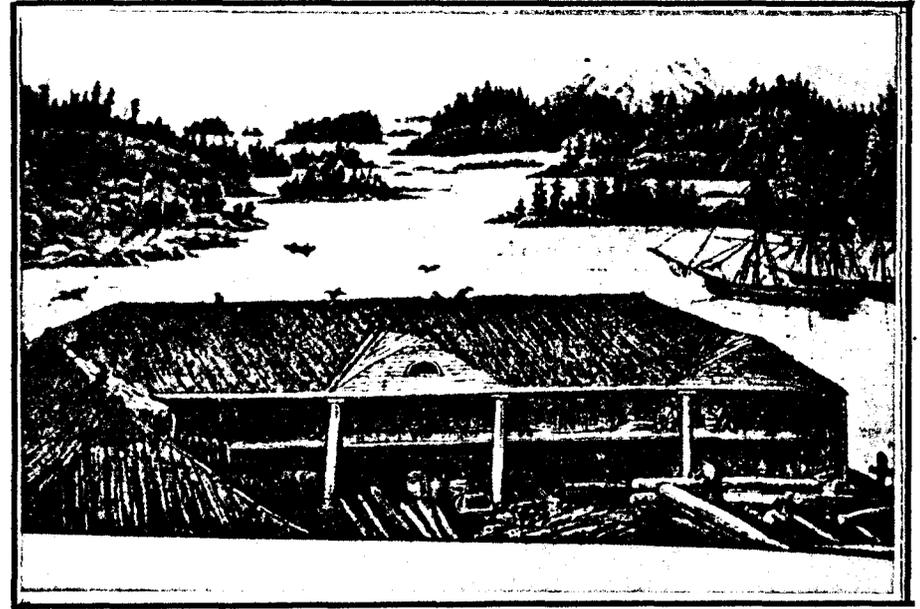
Figure 6. Warehouse in Sitka circa 1827 (Lutke 1835-36).

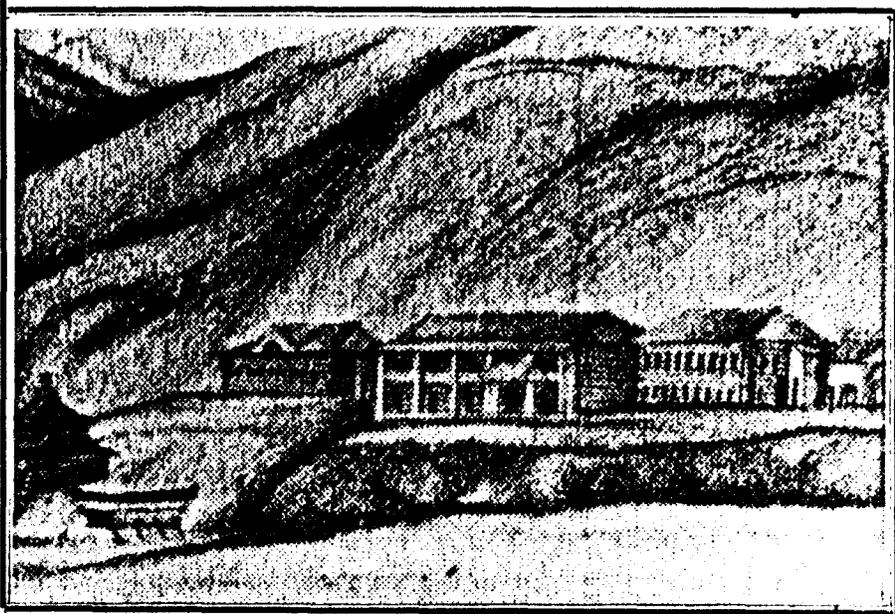
Figure 7. Warehouse in Kodiak, ca. 1842-43 (after Khlebnikov 1976: 8-9).

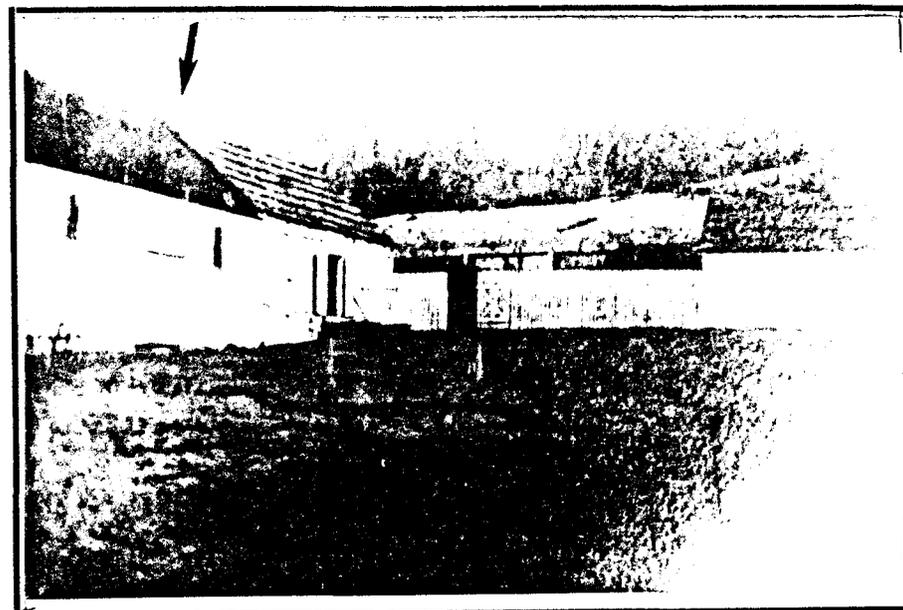
Figure 10. Photo of Dance Hall and shed circa 1878-1890s.

A drawing dated September 1878 shows two different buildings joined into one structure (O'Brien et al. 1980: end cover illustration). There is also a photo which shows the same structure, but the date on this is uncertain (Fig. 10). A survey made of the buildings on the Call Ranch by Frank B. Veasey in 1892 shows the building in that location to be 80 feet in length and 28 feet in width. However, in another photo of the building (circa 1890s) shows the northern addition to be missing (Fig. 11). Unfortunately, the Veasey map (Fig. 12) was made after the dismantling of most of the stockade walls, so it is hard to be sure of the measurements for the location of the building. This extension of 22 feet to the north would nicely coincide with a set of postholes and wooden timbers unearthed during the 1975-77 Cabrillo College excavations.

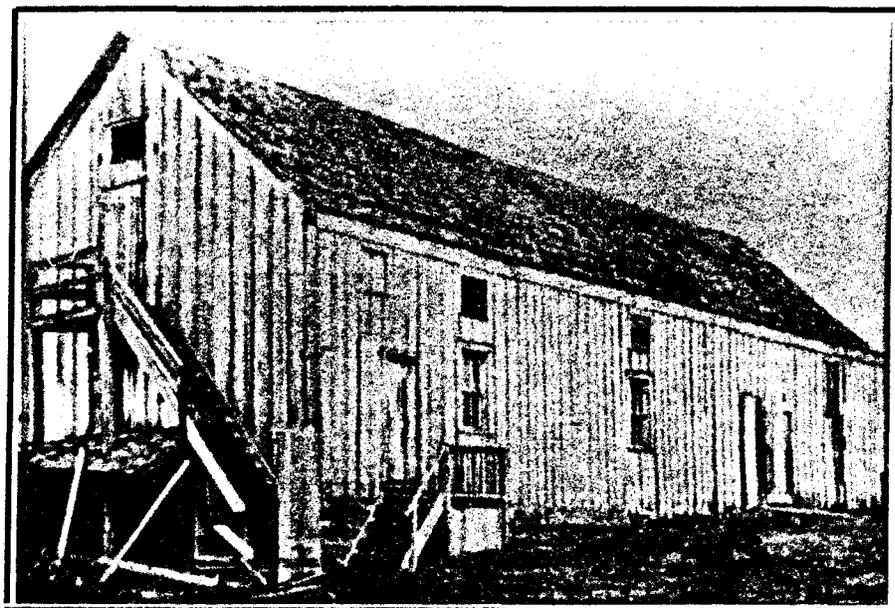
Figure 11. Photo of Dance Hall/Barn without shed--post-1892.

The soil immediately along the wall line was generally not hard-packed. However, in one area, from N62-64, the earth to the east of the wall line was extremely compact and had to be excavated with a pick. This area extended to the east approximately 1.5-2.0 meters. When excavated, it was found to contain a large quantity of artifacts datable to the late 19th century. It may be that this area formed the entrance to the large double door of the later 19th century (Fig. 11) structure and was not associated with the Russian structure.

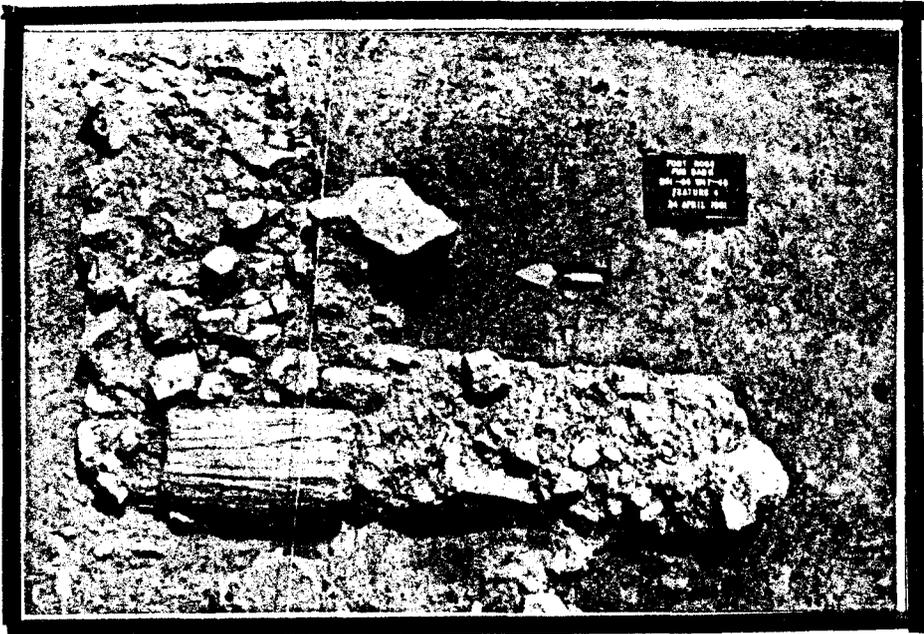
Figure 14. L-shaped footing for NW corner of the Old Magasin (Feature 4).

Perhaps the most important feature discovered was an L-shaped placement of stones (Feat. 4, Figs. 13 and 14) which had filled a pit of the same shape dug into the earth. Its grid location is N61.68-63.72, W47.3-48.7 (Fig. 13). This appears to be a foundation for the northwest corner of the original Russian structure. Immediately overlying part of the western portion of the feature is a 3 inch thick, 10.6 inch wide redwood board which is lying on the line of the west (or rear) wall. Whether this board truly dates back to the Russian period is uncertain. It most probably is derived from the later American structure which extended the original Russian building. It appears to be the remnant of a sill supporting the timber structure of the building.

A strong argument in support of this feature having underlain the northwest corner of the original Russian building is based on the fact that when the 1817 map detail is placed over a base map of the fort, the northwest corner of the Old Warehouse therein pictured lies directly over Feature 4.

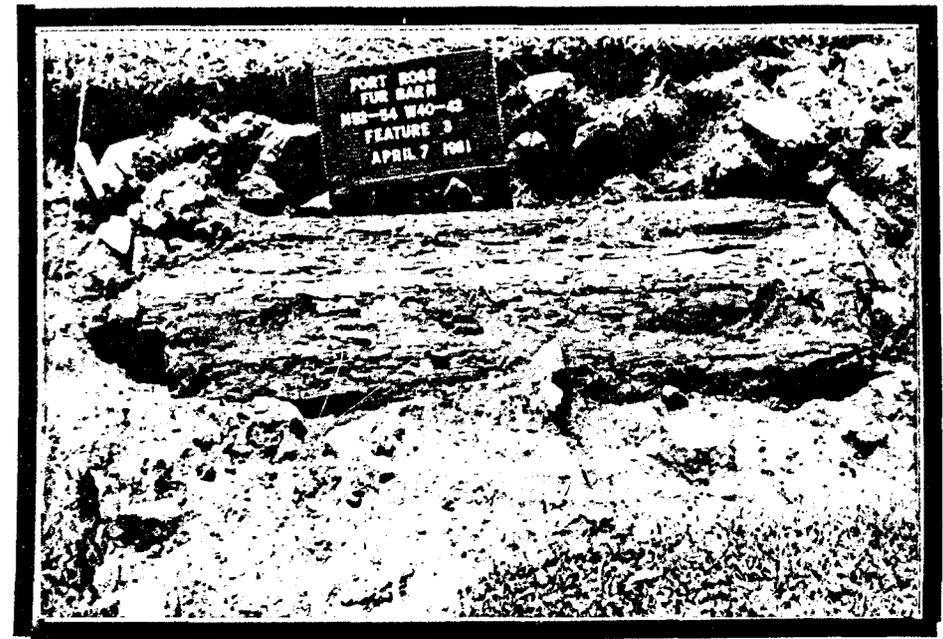
Figure 17. Wooden "Sleeper" along east wall line (Feature 3).

Feature 3 (Fig. 17) is a redwood board 1.2 meters (47 inches) long by 36 cm (14 inches) wide and 10.5 cm (4 3/8 inches) thick. This is oriented east-west and lies in what appears to be a purposely-constructed trough in the rocky fill. The board lies within the parameters N52.21-52.63, W39.96-41.20. The shape is somewhat curious. Although it has a fairly straight cut across the west end, its east end has a long diagonal cut combined with a notch. This piece was discovered to be in remarkably good condition which made it quite different from most of the rest of the wood found in the site. This is apparently due to a pitch material which coats the two cut ends to a thickness of about 1 cm. An initial impression that the pitch might have been applied was corrected by Mr. Emmet Crisp, a veteran log worker, who suggested that the wood had been cut and laid in "green" and the coating was an exudation from the wood itself. When the elevation was measured for the east and west ends of this sleeper, it was found that the east end was 7 cm (3 inches) lower than the west end. This would be acceptable given the hypothesis that the board was used to support a vertical column of the gallery which is said to have occupied the east side of the structure. Presumably, the extra weight on the east end resulted in that end being lower. The center of what I believe to be the load-bearing portion of the log is at N52.4.

Recently, Lester White, a dendrochronologist, has taken a sample from this specimen and suggested a cutting date of around 1834-1836 (White and Farris n.d.). This would fit with the hypothesis that there was rebuilding and reconstruction on this building going on in the mid-1830s.

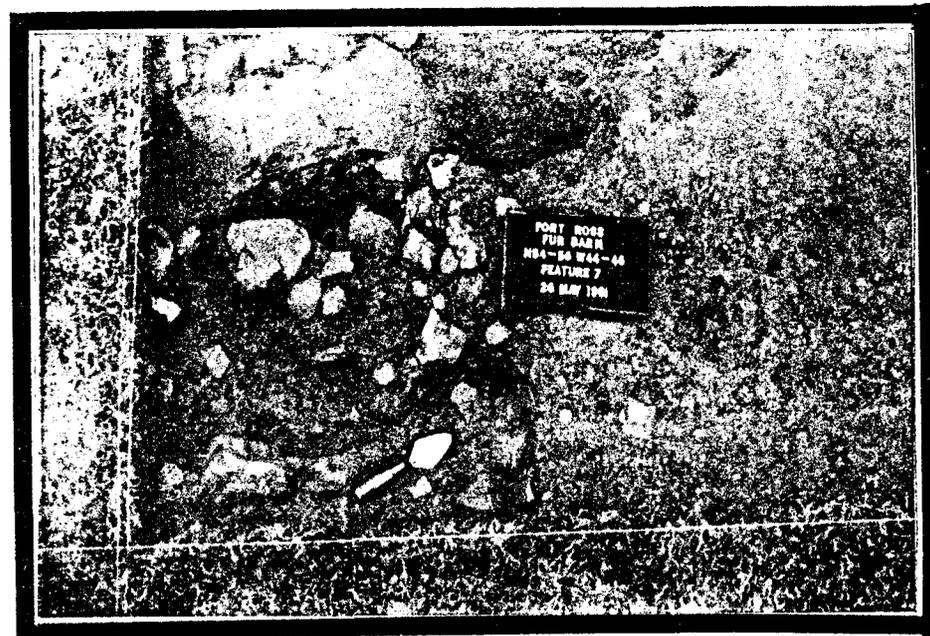
Figure 19. Sandstone boulder chipped off for a posthole (Feature 7) (Trowel points north).

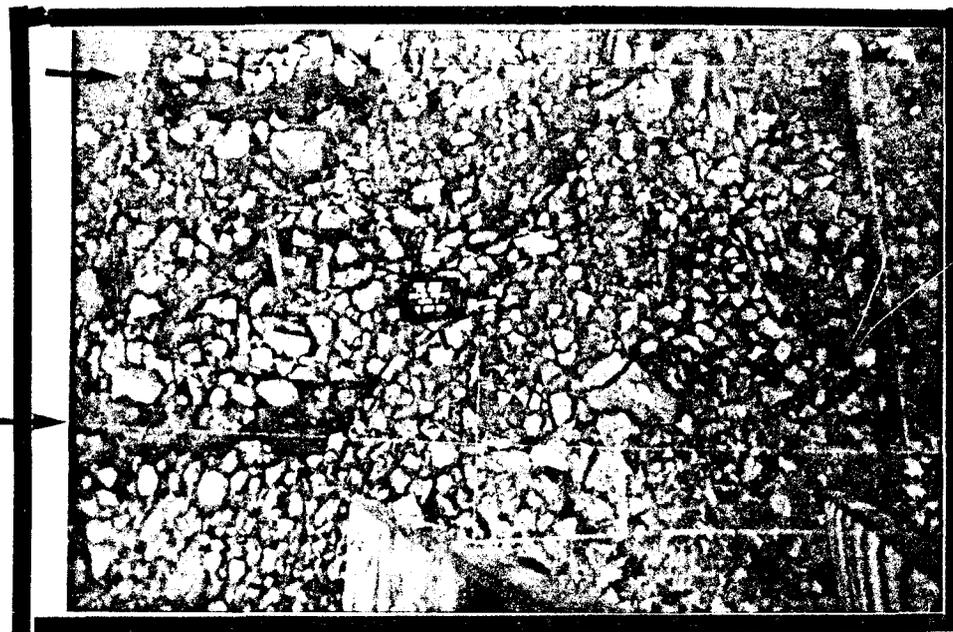
Figure 20. Features 15 and 16, two stone-lined troughs holding redwood planks (North is to right).

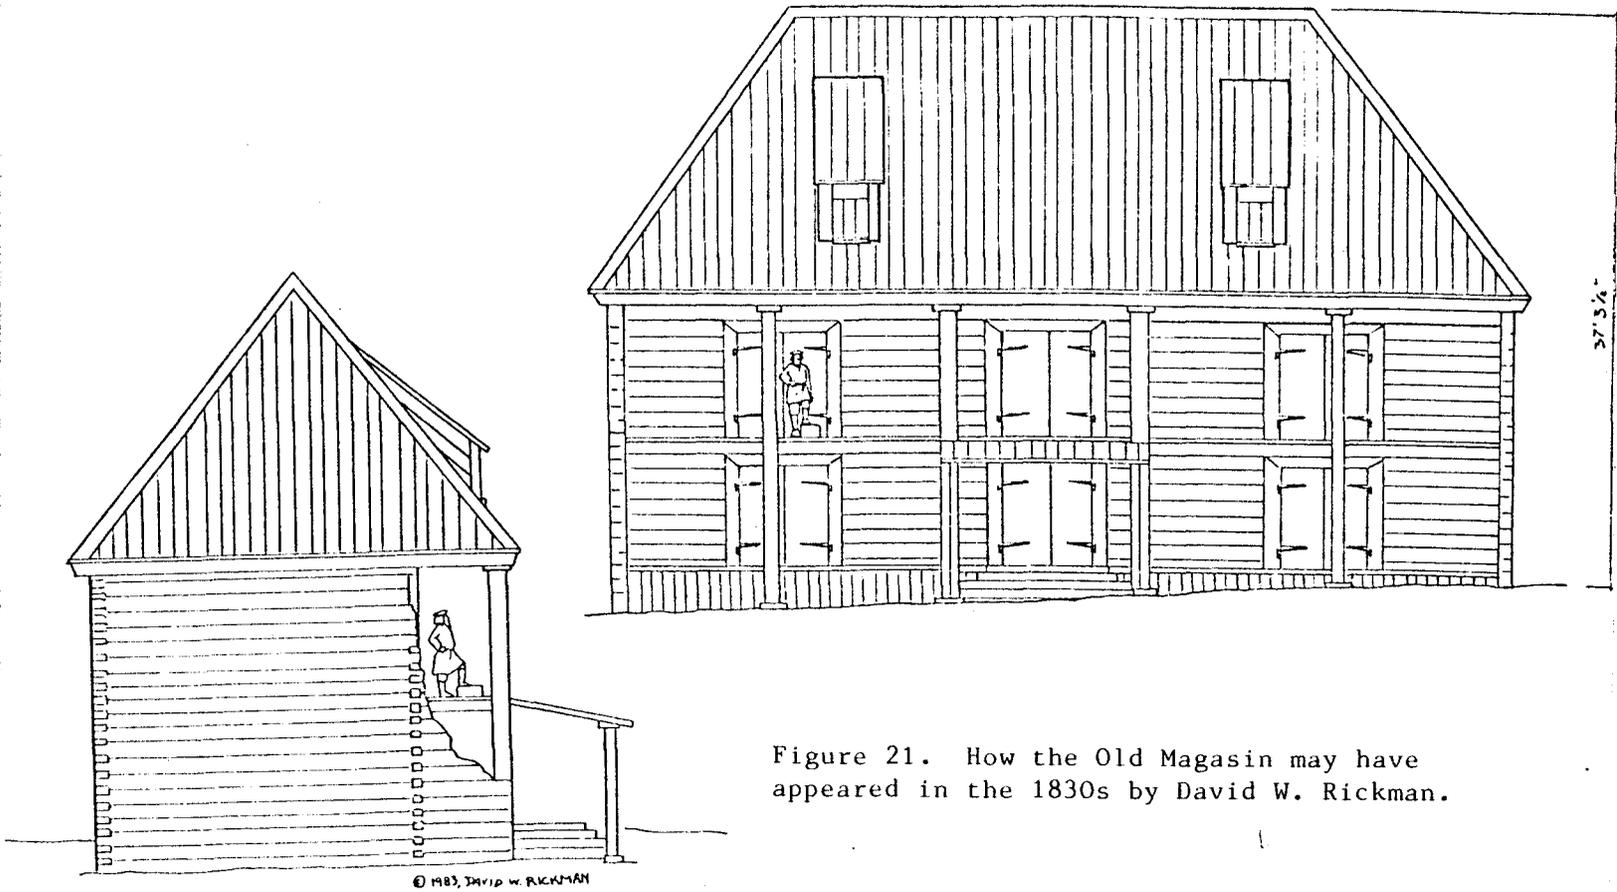
Figure 21. How the Old Magasin may have appeared in the 1830s by David W. Rickman.

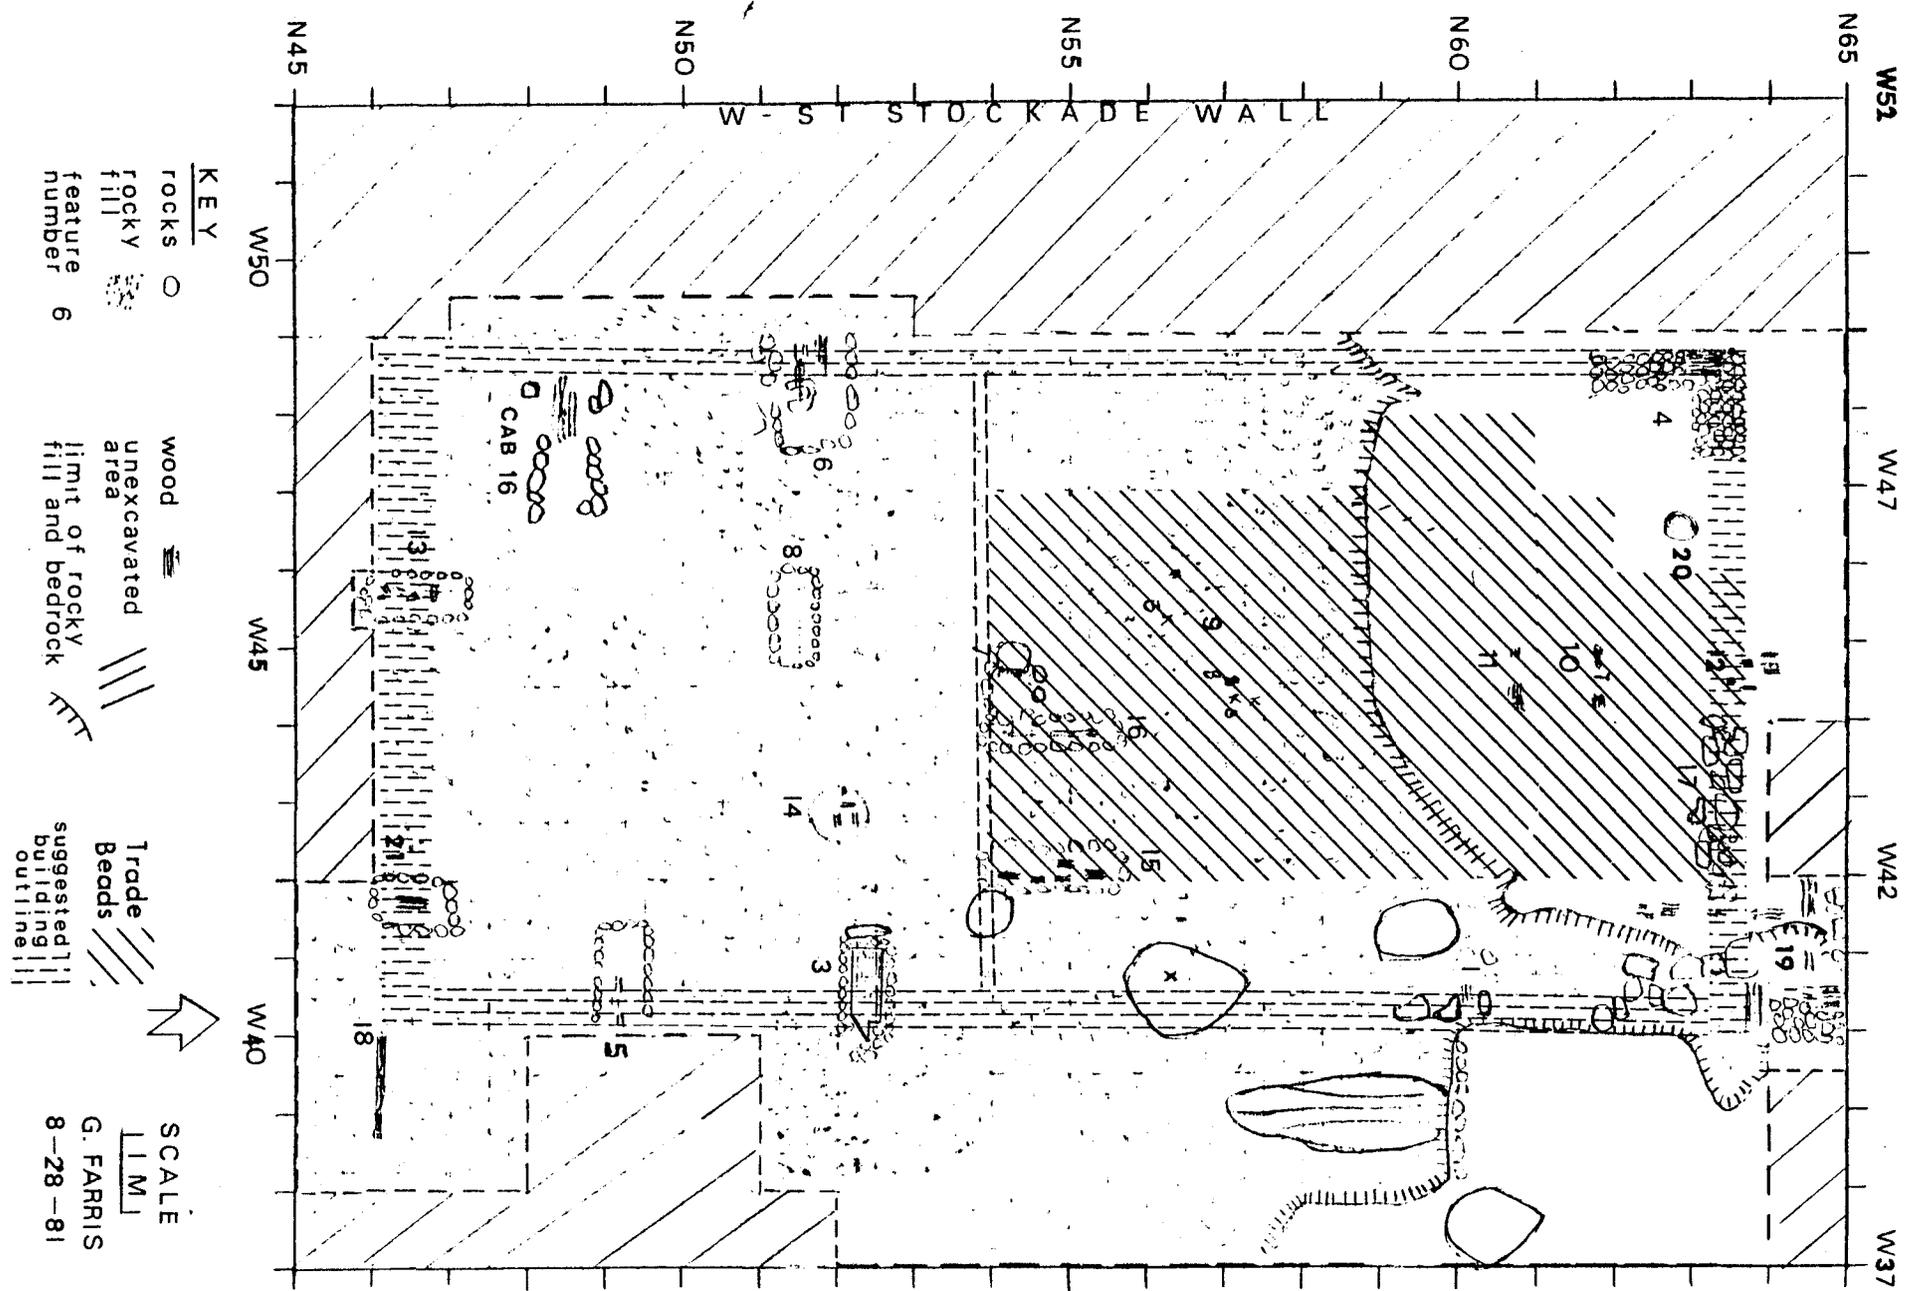
Figure 22. Plan Map of the 1981 Excavations showing bead concentrations and a projected outline of the building boundaries.

Having said this, I would like to point out one likely artifact type which probably dates to the Russian occupation. It is particularly worthy of mention because of its interesting spatial distribution. A remarkably large number of colored glass trade beads (Fig. 23) were found in the north-central area. Although a persistent scatter had been found at some points along the periphery of the building, as well as in the southern portion, the overwhelming majority were found concentrated in an area 10 meters long (N-S) by 4 meters wide (E-W). The general parameters were N54-64, W42-46 (Fig. 22). The highest concentrations within the area were toward the center. Over 220 beads were recovered from this area of 40 m<sup>2</sup>. What is particularly interesting is the likelihood that the distribution of the beads may help to define the room in which they were being stored within the Fur Warehouse. Assuming there were two rooms, a north and a south room divided about the line N54, then the beads were apparently stored in the north room. They were small enough to have sifted through the floorboards of even a fairly tight floor. The beads are also useful in confirming the north end of the Russian period structure as only one bead was found north of the apparent north wall line during the Cabrillo College excavations which carefully dug ten 2x2 meter units to the north of the building. However, Cabrillo recovered 4 beads from units within the area of the Russian Fur Warehouse, an area in which they had dug only five 2 x 2 meter units (or 34% of their total excavation).

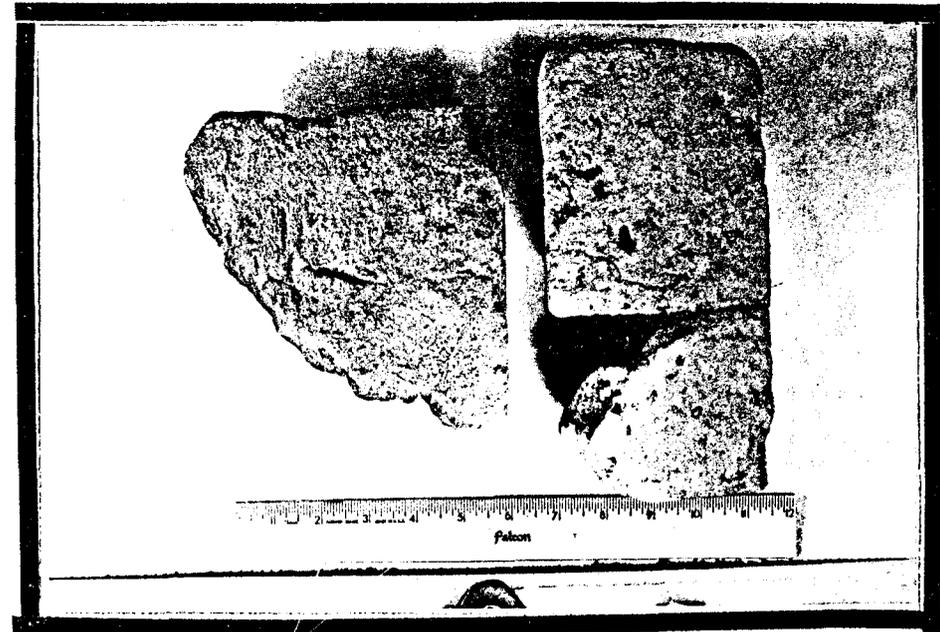
Figure 24. Two bricks recovered from the site. On left is a "Russian" brick; to right is "American" size.

Only seven fragments of "Russian" bricks (and no whole ones) were found. These bricks are distinguishable in part by their larger size, particularly the width dimension (Fig. 24). This is usually 5 1/4 to 6 inches (13-15 cm). These were mostly concentrated at the extreme northeast corner of the building and seem to be only rubble fill, not structural of themselves. Von Wrangell tells

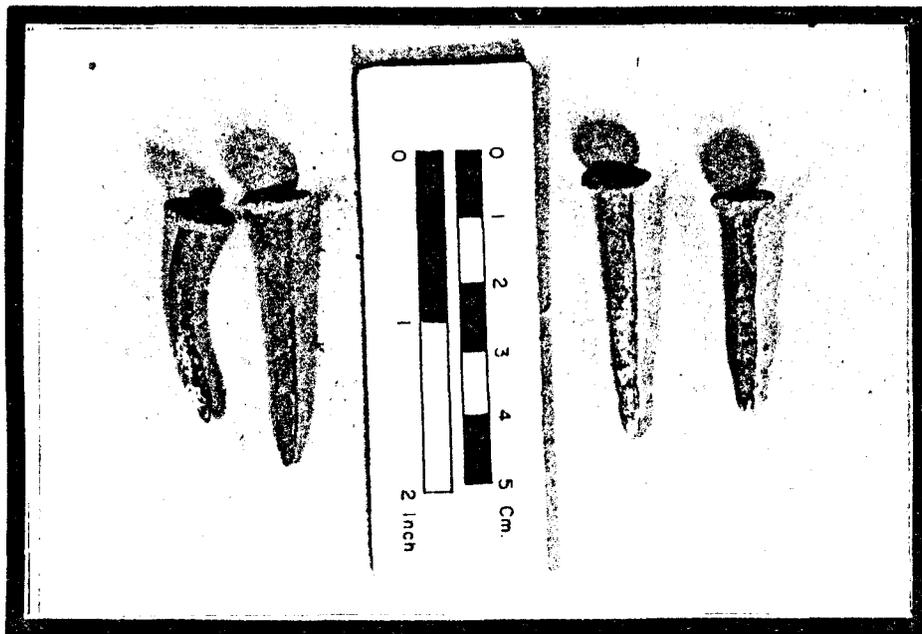
Figure 25. Four brass/copper nails from the site. Similar to ones from Sitka Bishop's House.
